Bedrock Community Benefits Agreement Term Sheet

BEDROCK | CUYAHOGA RIVERFRONT MASTER PLAN

FINDINGS AND CONTRIBUTING FACTORS

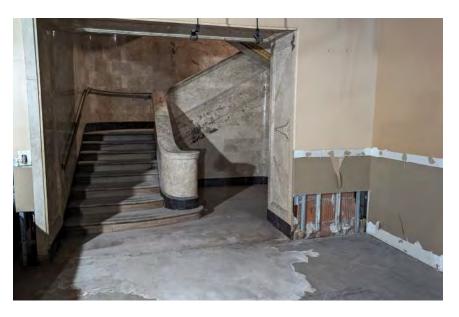
Deterioration of structures, roads, sidewalks, or infrastructure is another key sign of blight that can reduce the value of surrounding property, encourage crime, or compromise public health and safety. An overwhelming percentage (>68%) of blighted parcels in the area appear dilapidated or deteriorated. Deterioration of buildings, roads, sidewalks, and infrastructure on this site all contribute to the area's blight.

Deteriorating floors, walls, and stairwell in the Tower City building associated with Raisin Industry Parcels

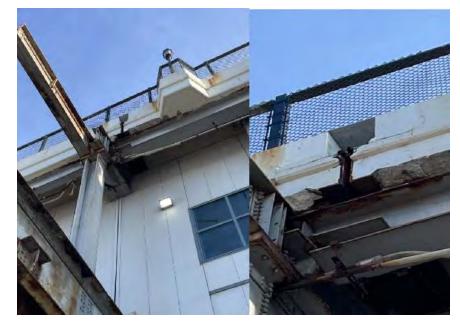
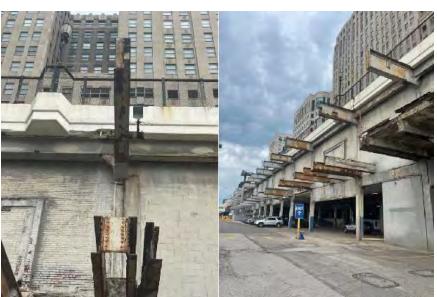
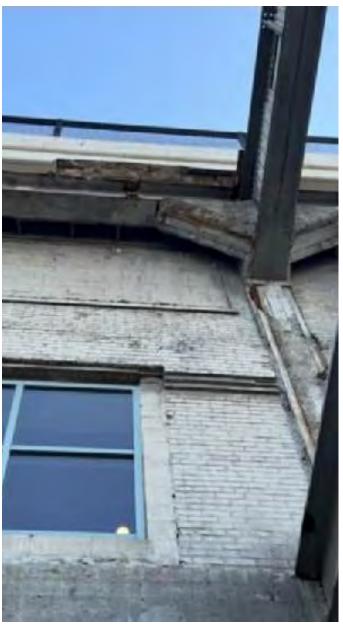
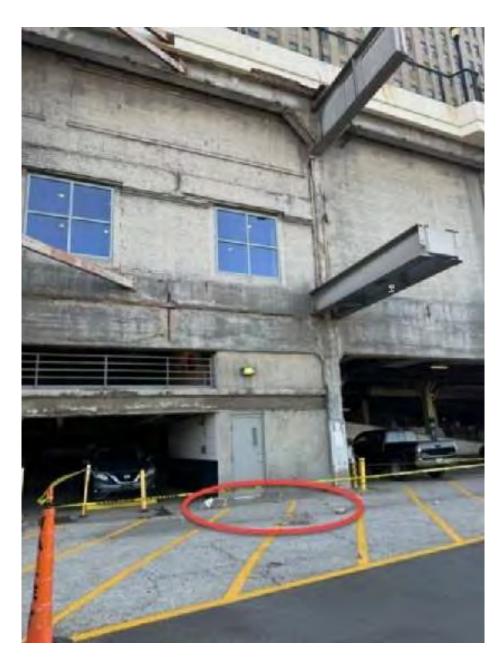
Deteriorating beams, parapet, and crumbling concrete on the exterior of Raisin Industries parcels.

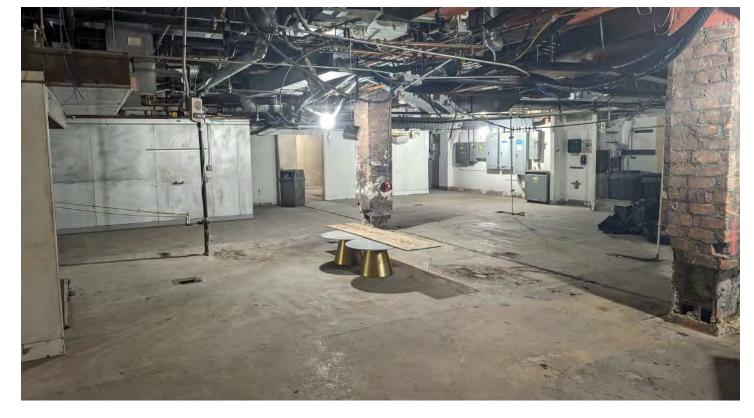
The most prevalent signal of blight in the plan area is the aging and obsolescent structures and infrastructure. This applies to 84% of blighted parcels. The average year of construction for buildings in the plan area is 1965. The Ohio Revised Code does not specify an age at which buildings may be deemed 'aged,' but generally, 50 years old is when a building enters the "old age" stage of its life cycle.

Exposed overhead wires, dilapidated flooring, and crumbling brick associated with Raisin Industry Parcels.

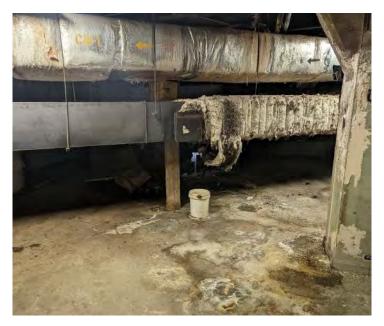
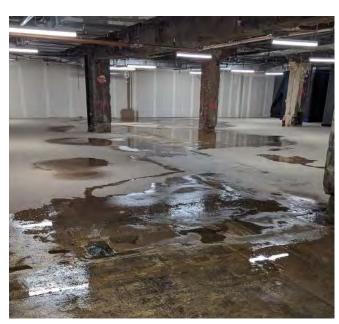
Nineteen parcels in this study area meet this criteria. Several parcels lack any natural light or electricity-powered light, posing a tripping hazard. Other parcels lack adequate air ventilation and as a result, are prone to the spread of rust and/or mold.

Poor ventilation highlighted by damp conditions and standing water causes paint to peel and fosters the growth of mold and mildew associated with Raisin Industry Parcels.

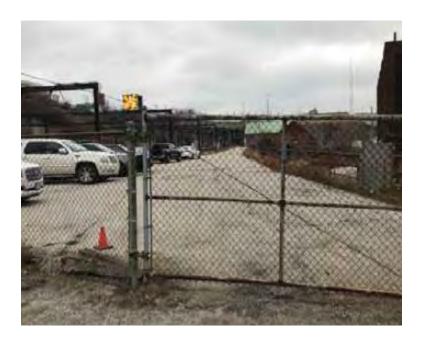
Six properties in the Blight Study site are hazardous to lives due to the presence of subsurface contaminants that present a potential exposure risk to human health and the environment.

Left: Outdoor parking lot that was found to have hazardous levels of subsurface contaminants.

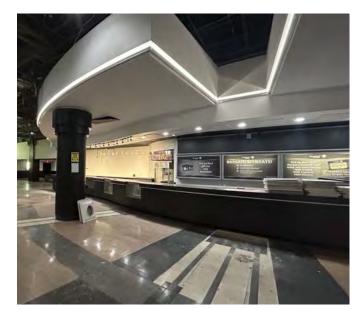
Examples of additional indoor vacancies in Tower City.

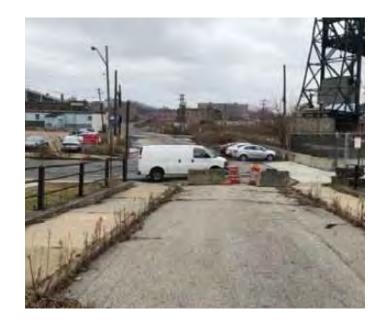
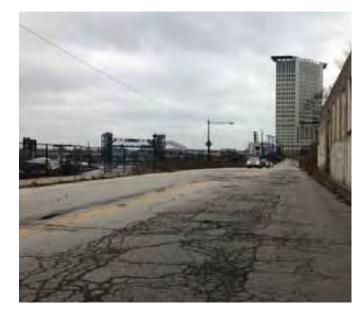
35 parcels on this site are in areas with defective or inadequate street layouts. This reduces the ease of mobility and navigation and compromises accessibility of an area. Many streets in the plan area lack sidewalks on at least one side of the street or have uneven, deteriorating sidewalks that are covered in weeds. One street in the plan area is closed off, prohibiting travel on Eagle Ave between Canal Rd to the east and W Third St to the west.

Road closure at Stones Levee Road and lack of sidewalks create a defective street layout in the study area.

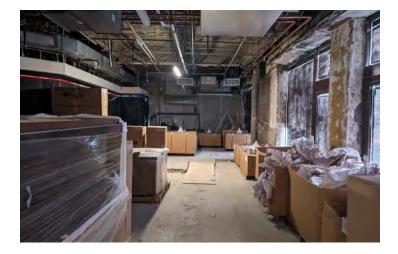
Many of these parcels fall within Tower City, and by their confined or parcellocked nature are deemed inadequate or inaccessible for future use of the parcel.

Parcels in the Tower City building with faulty layouts present accessibility and usability challenges.

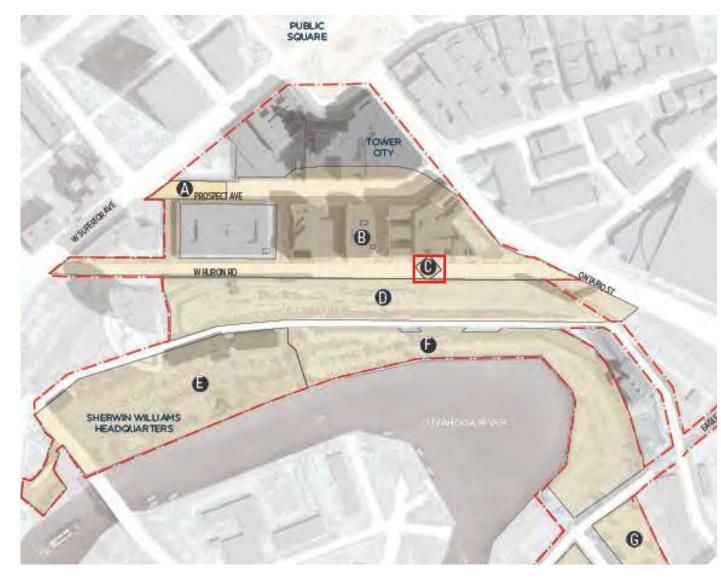
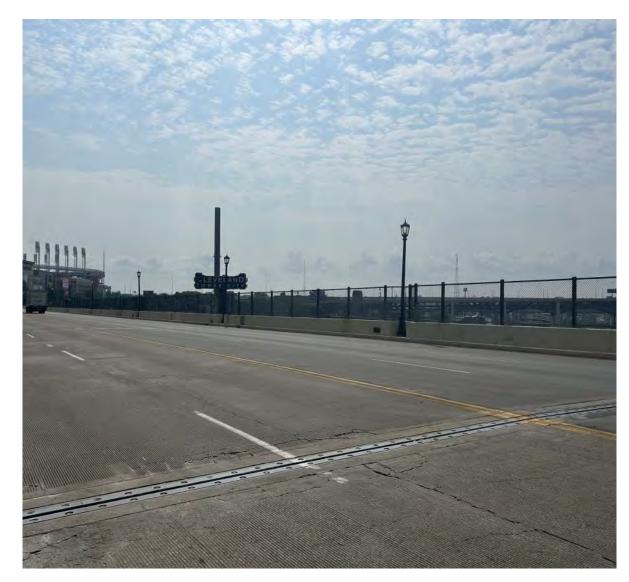
Parcel C

Land Development Criteria		
Applicable Blight Criteria	B2(j) - Parcel is located in an area with defective or inadequate street layout B2(l) - Parcel exhibits faulty lot layout in relation to size, adequacy, accessibility, or usefulness	
Comments	 B2(j) - Adjacent lot line of previous right of way abandoned. B2(l) - Current layout separates parking area by limiting available spaces in connection with adjacent parking 	
Supporting Documents	Parcel description has no lower limit and an upper limit of 70.40'. See photos for additional supporting evidence.

B2(j) Parcel is located in an area with defective or inadequate street layout

B2(I) Parcel exhibits faulty lot layout in relation to size, adequacy, accessibility, or usefulness

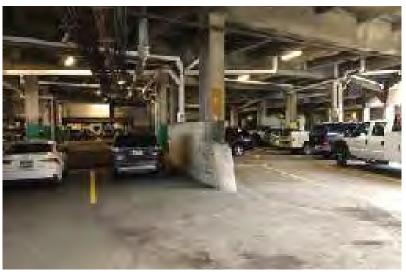
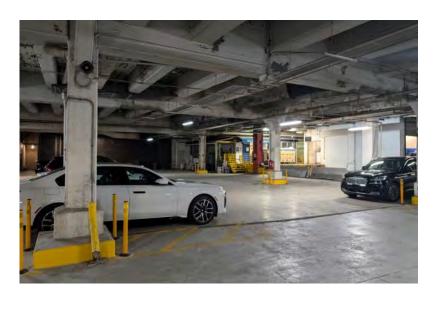
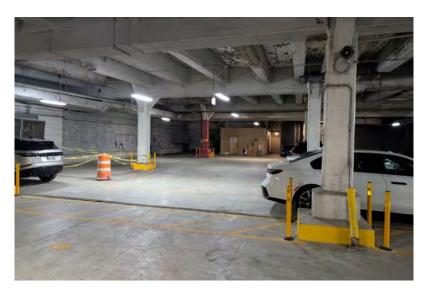
Parcel B

Land Development Criteri	a
Applicable Blight Criteria	B2(a) Parcel exhibits dilapidation and deterioration B2(b) Parcel exhibits age and obsolescence
Comments	 B2(a) - Several areas of standing water causing pavement failures over time B2(b) - Life cycle of exiting infrustructure is passed, for example, concrete spalling and cracked asphalt
Supporting Documents	See photos for additional supporting evidence.

B2(a) Parcel exhibits dilapidation and deterioration

B2(b) Parcel exhibits age and obsolescence

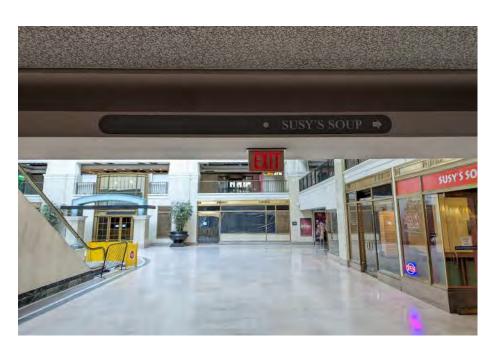
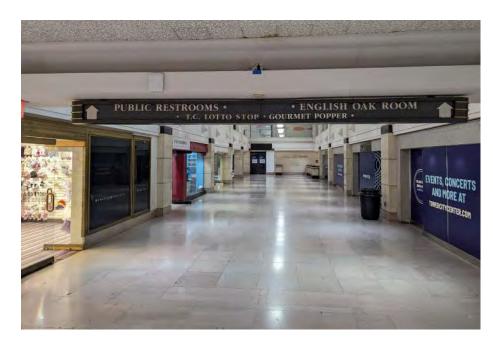
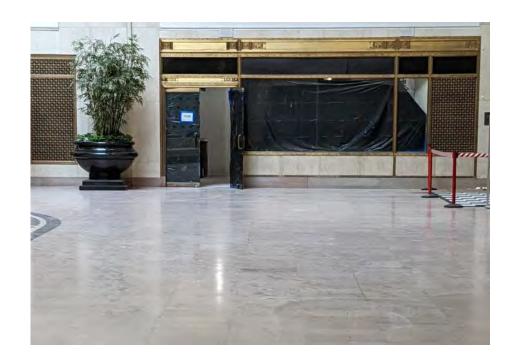
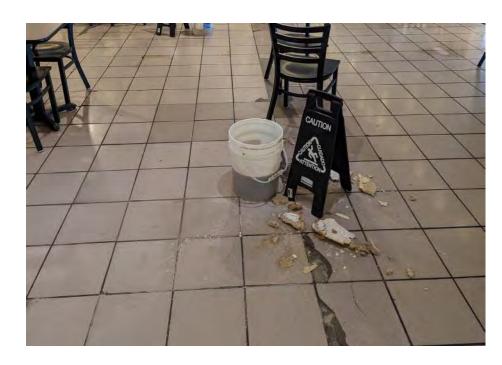
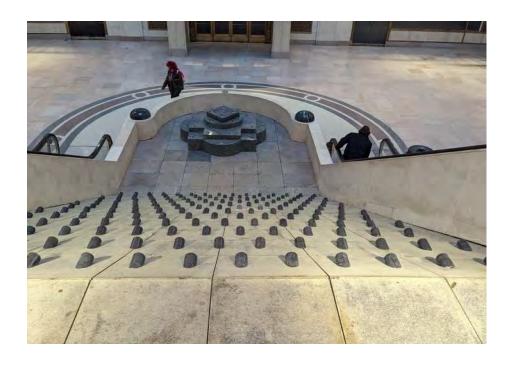
101-23-072A-F
B2(a) Parcel exhibits dilapidation and deterioration
B2(b) Parcel exhibits age and obsolescence

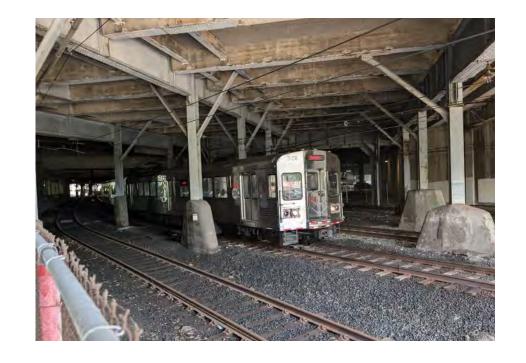
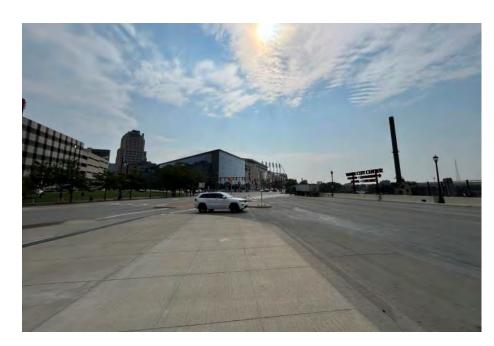
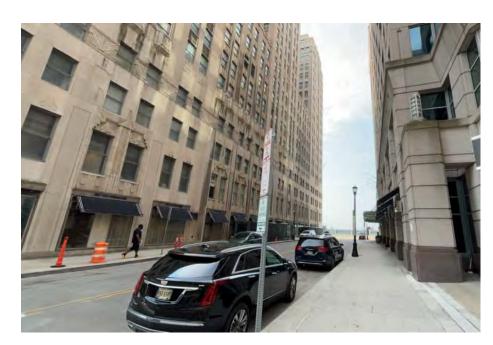
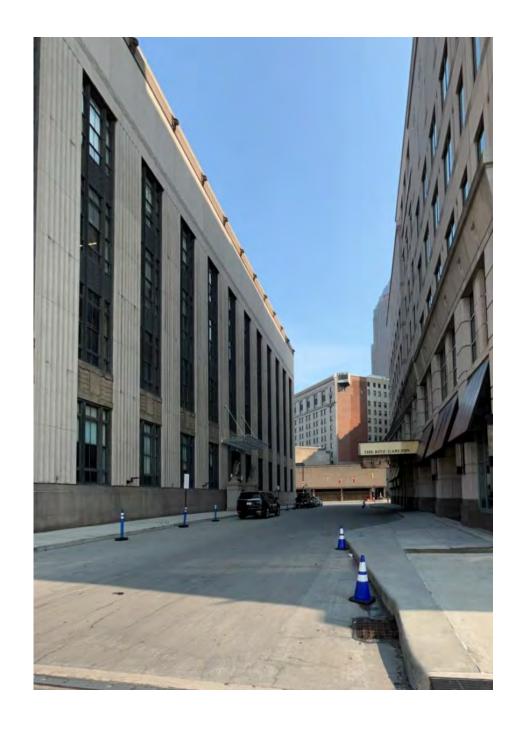
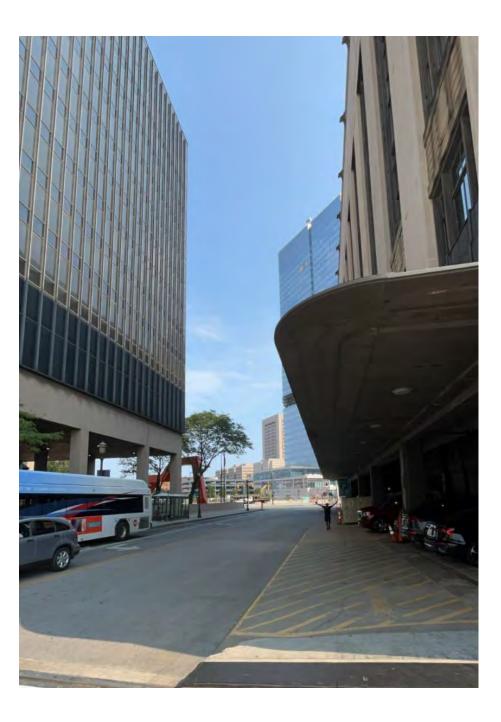
101-23-072G-J
B2(a) Parcel exhibits dilapidation and deterioration
B2(b) Parcel exhibits age and obsolescence

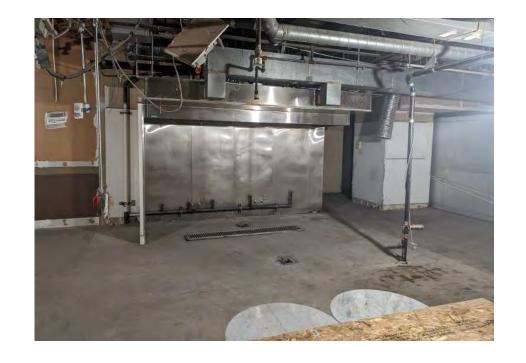
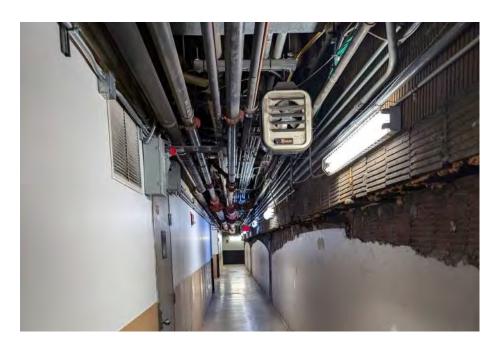
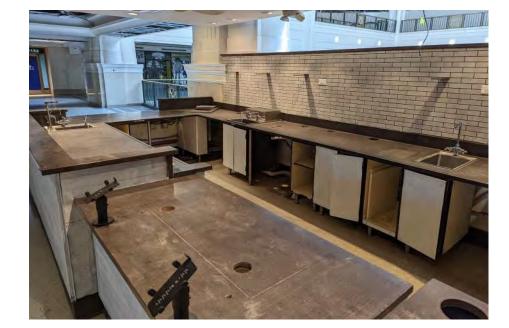
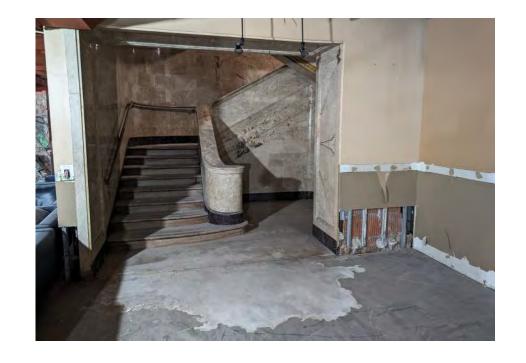
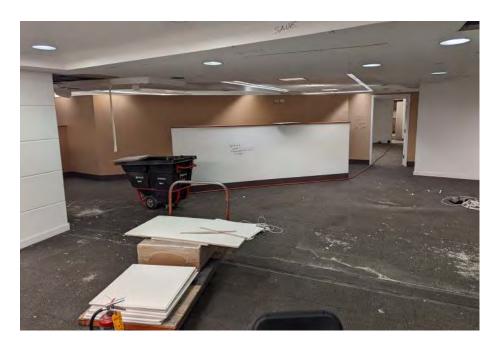
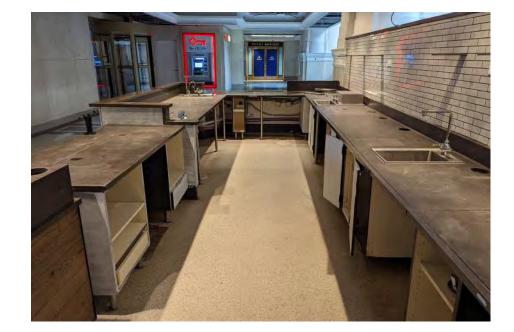
101-23-085B-E
B2(a) Parcel exhibits dilapidation and deterioration
B2(b) Parcel exhibits age and obsolescence

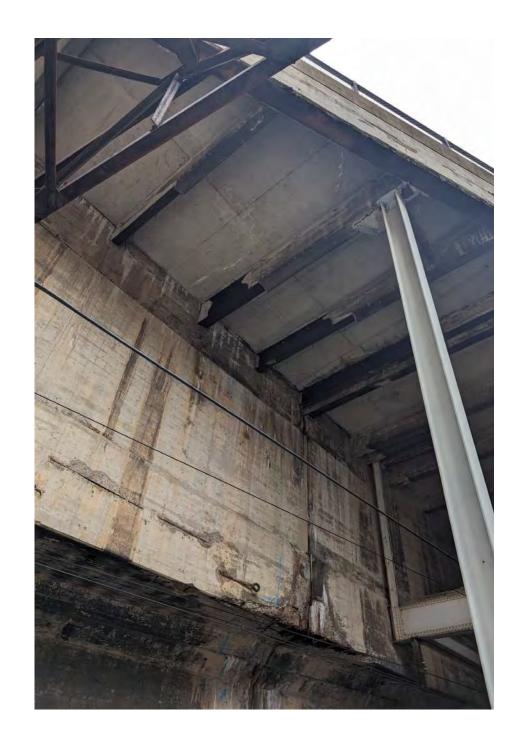
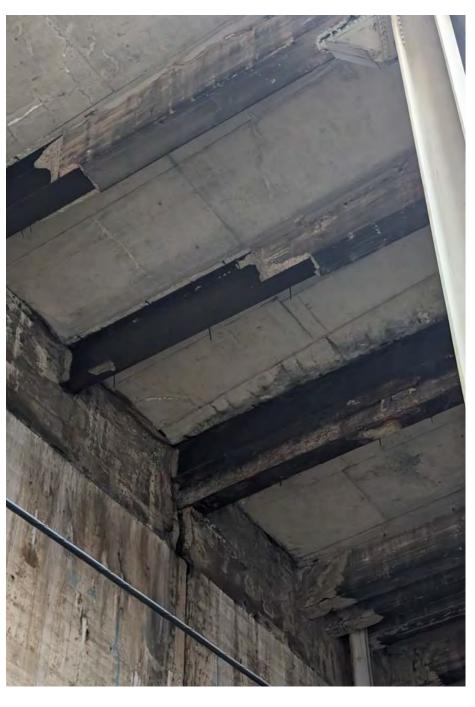
101-23-072H
B2(a) Parcel exhibits dilapidation and deterioration
B2(b) Parcel exhibits age and obsolescence

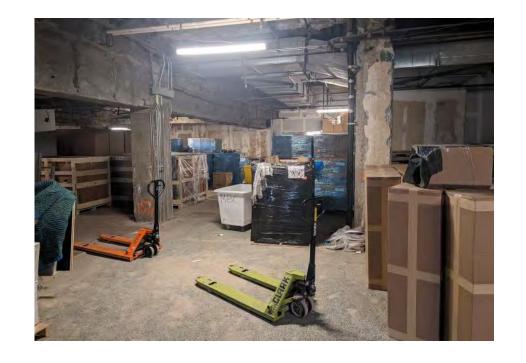
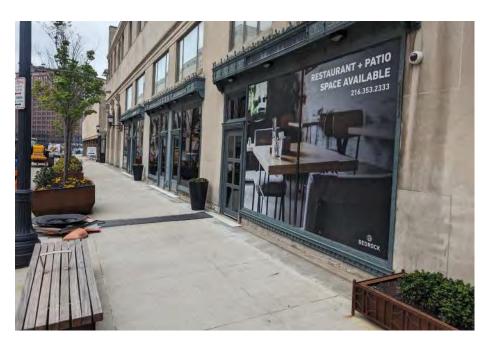
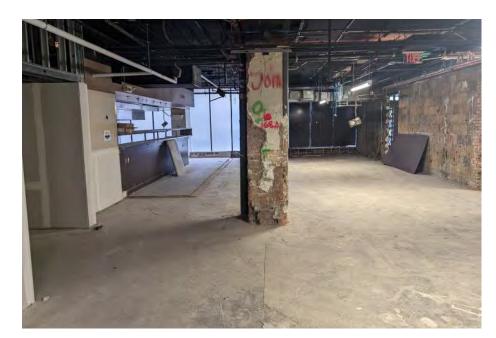
101-23-100A
B2(a) Parcel exhibits dilapidation and deterioration
B2(b) Parcel exhibits age and obsolescence

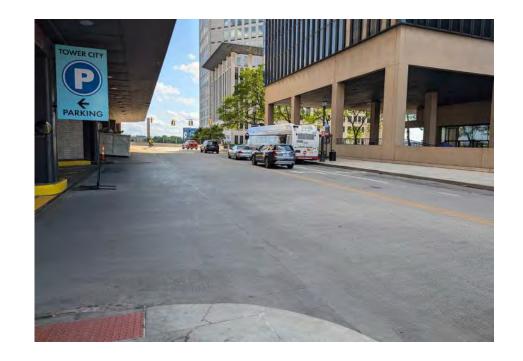
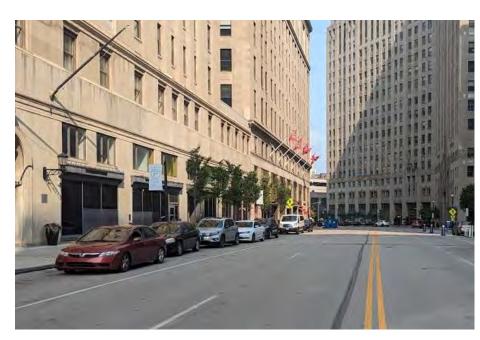
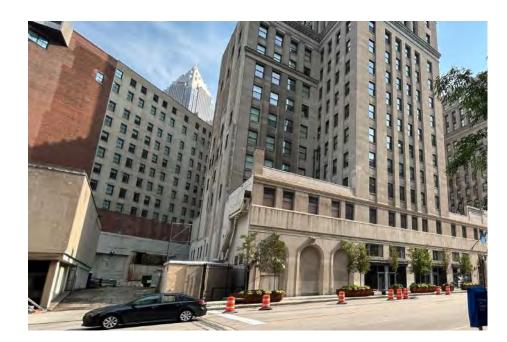
101-23-100H-K
B2(a) Parcel exhibits dilapidation and deterioration
B2(b) Parcel exhibits age and obsolescence

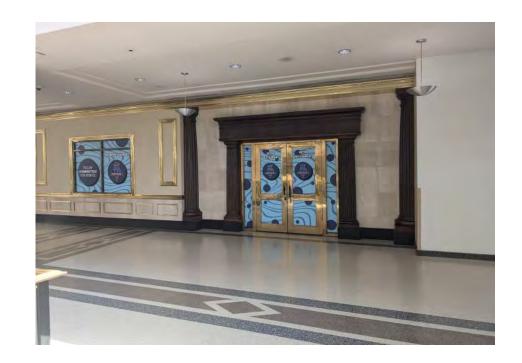
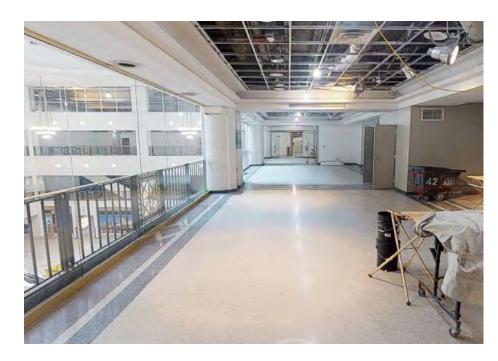
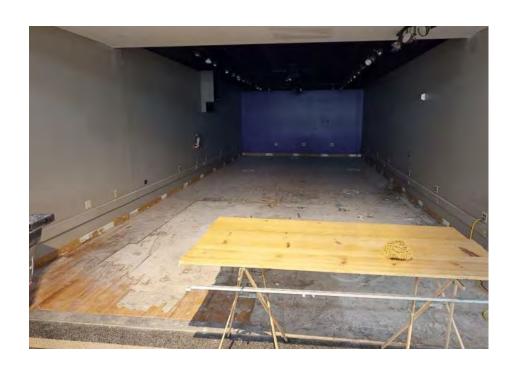
101-23-100P-S
B2(a) Parcel exhibits dilapidation and deterioration
B2(b) Parcel exhibits age and obsolescence

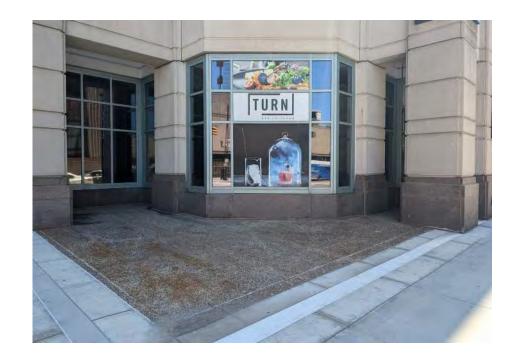
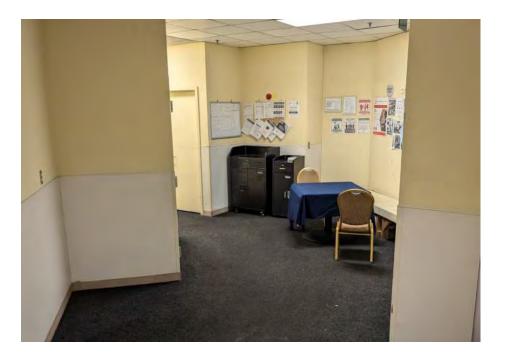
101-23-101F
B2(a) Parcel exhibits dilapidation and deterioration
B2(b) Parcel exhibits age and obsolescence

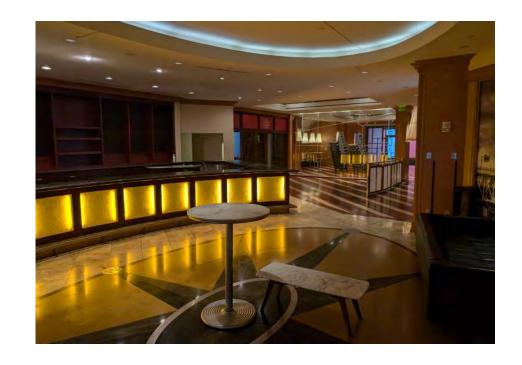
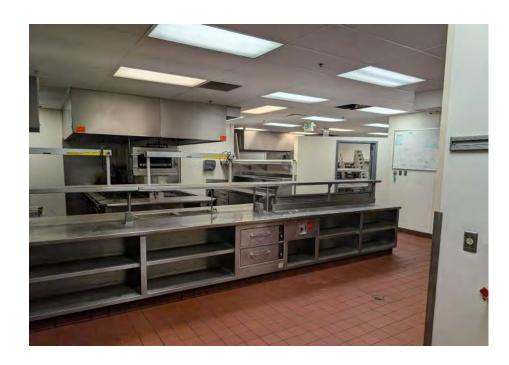
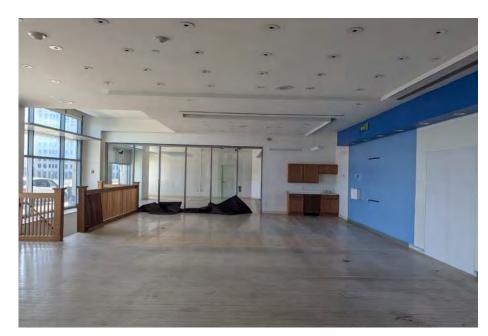
101-23-103F & 108F
B2(a) Parcel exhibits dilapidation and deterioration
B2(b) Parcel exhibits age and obsolescence

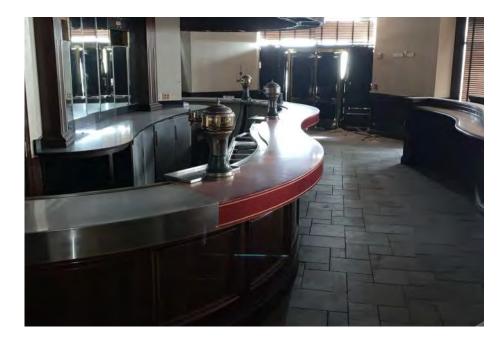
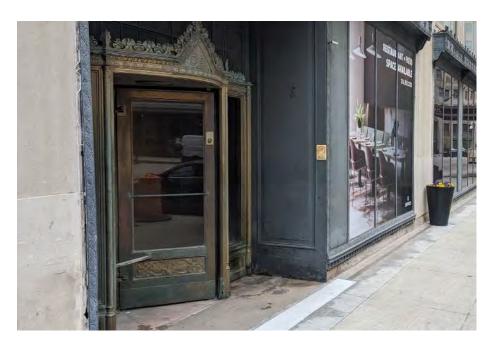
Land Development Criteria	
Applicable Blight Criteria	B2(b) Parcel exhibits age and obsolescence B2(c): Parcel exhibits inadequate provision for ventilation, light, air, sanitation, or open spaces
Comments	 B2(b) - Life cycle of exiting infrustructure is passed, for example, concrete spalling and cracked asphalt B2(c): Lack of daylight, powered lights in areas are triping hazzards common for pedestrians. Rusty/Moldy air quailty.
Supporting Documents	See photos for additional supporting evidence.

101-23-085A & 100C
B2(b) Parcel exhibits age and obsolescence
B2(c): Parcel exhibits inadequate provision for ventilation, light, air, sanitation, or open spaces

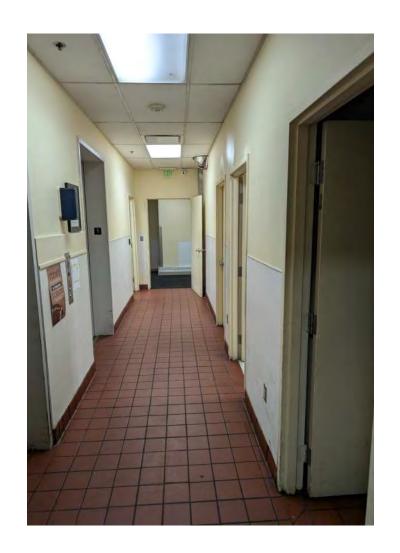
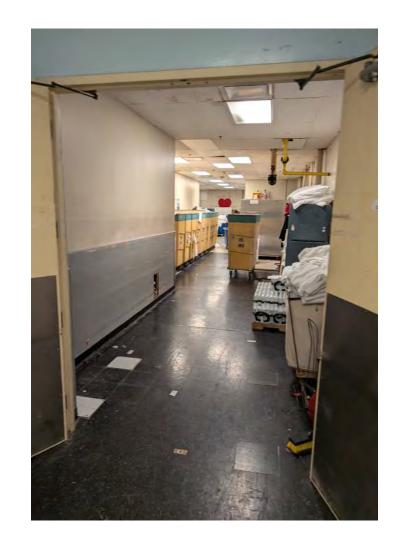
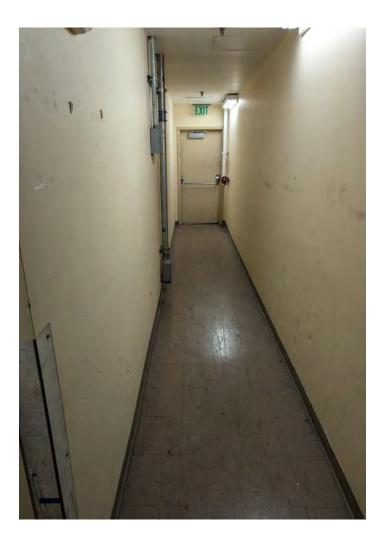
Land Development Criteria	
Applicable Blight Criteria	B2(a) Parcel exhibits dilapidation and deterioration B2(b) Parcel exhibits age and obsolescence
Comments	 B2(b) - Life cycle of exiting infrustructure is passed, for example, concrete spalling and cracked asphalt B2(c): Lack of daylight, powered lights in areas are triping hazzards common for pedestrians. Rusty/Moldy air quailty.
Supporting Documents	See photos for additional supporting evidence.

101-23-072D, 101-23-72E, 1010-23-85G, 101-23-106F, 101-23-104F B2(a) Parcel exhibits dilapidation and deterioration B2(b) Parcel exhibits age and obsolescence

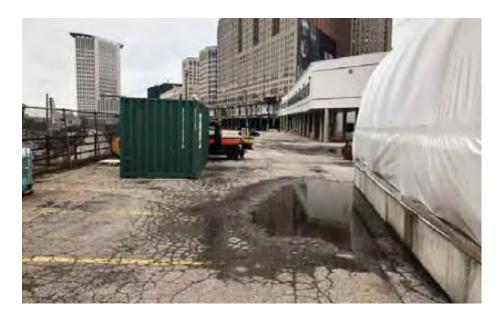
Environmental Criteria	
Applicable Blight Criteria	B2(e) Parcel contains hazards that endanger lives or properties by fire or other causes B2(f) Parcel is noncompliant with building, housing, or other codes
Comments	 B2(e) - The identified subsurface contaminants present a potential exposure risk to human health and the environment. B2(f) -Environmental contamination exists at concentrations above Ohio EPA generic standards for hazardous substances
	 Recognized Environmental Conditions The presence of contamination on the Subject Property associated with the long historical industrial use of the Subject Property, including a foundry, a paint company, a paraffine company, a box factory and a scrap iron yard, is considered to be a "recognized environmental condition" associated with the Subject Property. The potential for contamination to have migrated onto the Subject Property from the eastern adjacent land based on the long historical industrial use of the eastern adjacent properties, including a nickel plating facility, a chemical manufacturer, a paraffine company and an oil warehouse, is considered to be a "recognized environmental condition" associated with the Subject Property. The potential for contamination to have migrated onto the Subject Property from the western adjacent land based on the long historical industrial use of the western adjacent properties, including machine shops, a chemical warehouse and an aluminum anodizer company, is considered to be a "recognized environmental condition" associated with the Subject Property.

B2(e) Parcel contains hazards that endanger lives or properties by fire or other causes

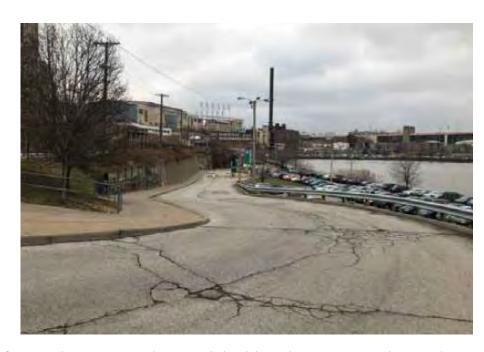
B2(f) Parcel is noncompliant with building, housing, or other codes

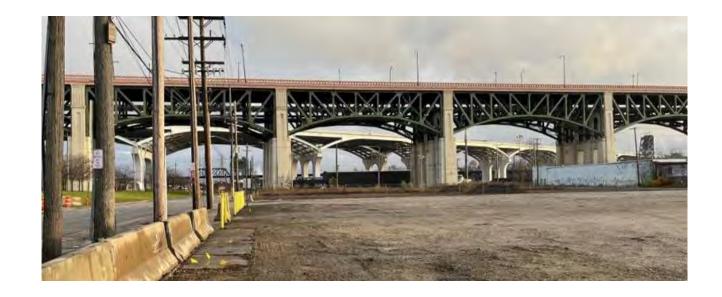
B2(h) Parcel is vacant or contains an abandoned structure

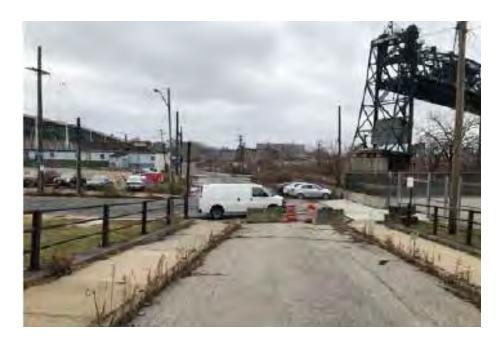
B2(j) Parcel is located in an area with defective or inadequate street layout

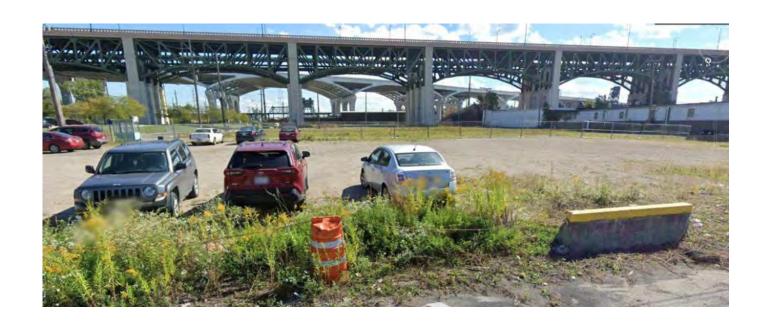
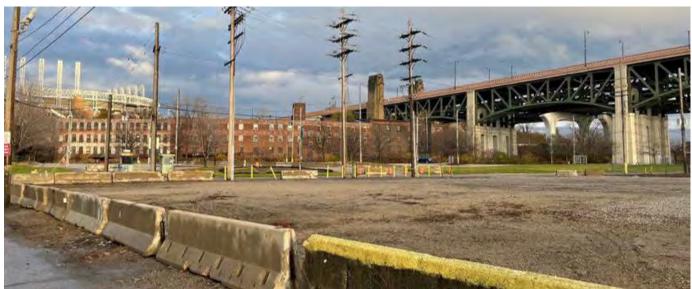
Land Development Criteri	a
Applicable Blight Criteria	B2(h) Parcel is vacant or contains an abandoned structure B2(j) Parcel is located in an area with defective or inadequate street layout
Comments	 B2(h) - Site is Vacant (parking overflow) B2(j) - Inefficent and outdated road network for site access.
Supporting Documents	Issued for construction Building & Houosing Permit# B23022646
	See photos for additional supporting evidence.

B2(j) Parcel is located in an area with defective or inadequate street layout
B2(h) Parcel is vacant or contains an abandoned structure
