Subject: *2018 Capital Repair Audit of First Energy Stadium*

2018 CAPITAL REPAIR AUDIT FOR FIRSTENERGY STADIUM FOR THE CITY OF CLEVELAND

OSBORN ENGINEERING
FEBRUARY 11, 2019

Re: 2018 Capital Repair Audit of FirstEnergy Stadium (Rev #1)

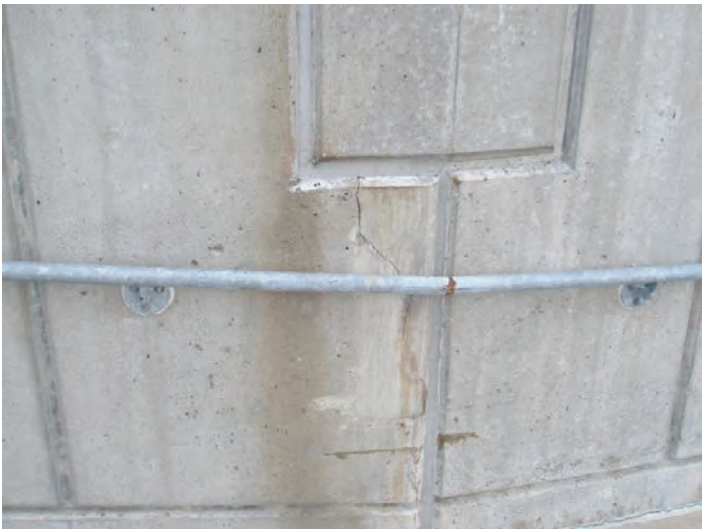
C1 - Typical Structural crack in retaining wall

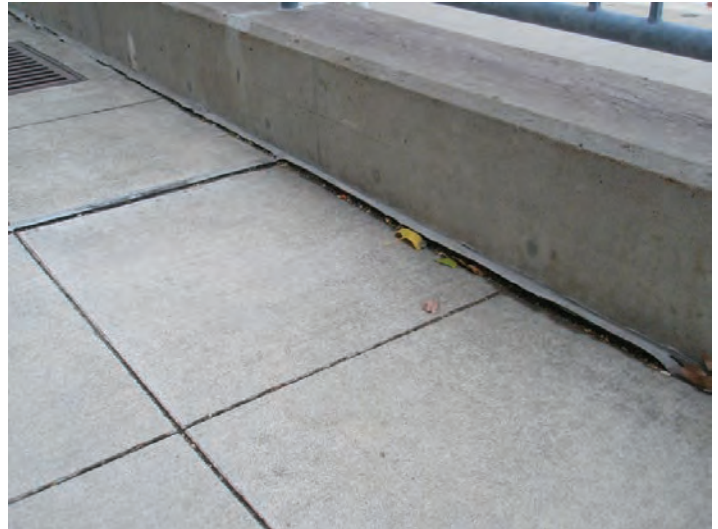
C3 - Typical failed sealant on plaza

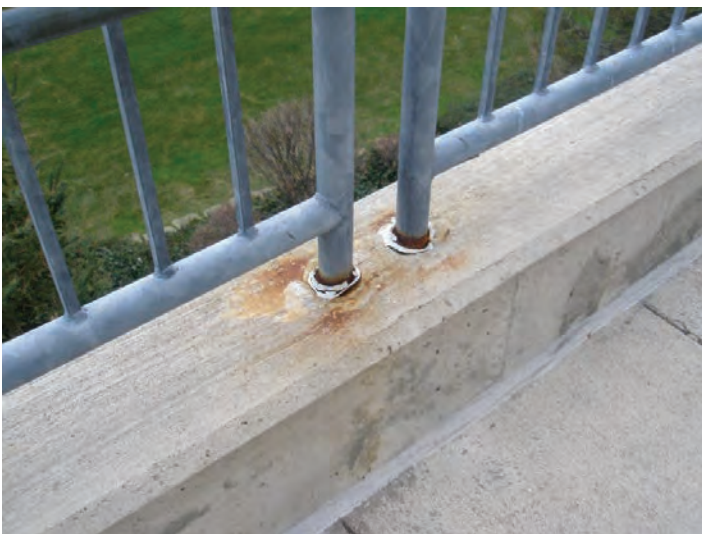
Guard rail posts: We observed deterioration of the concrete at several guard rails posts atop retaining walls and edges of elevated plazas. Considering the number of guard rail posts on the site the number of observed failures is considered very low. See Photo C-2.

C2 - Typical failed sealant at guardrail post

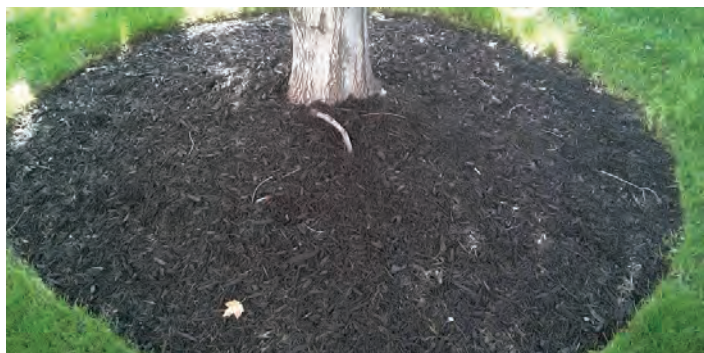
Nearly all of the remaining trees are over-mulched. See Photo L1. This has and will continue to result in root girdling of the trees and their quickened demise.

L1 - Over-mulching around trees

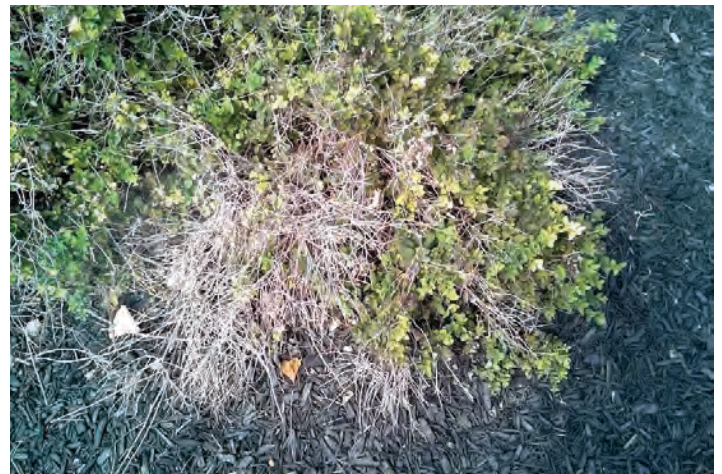
L2 - Little Princess Spirea in poor condition fixture in concourse

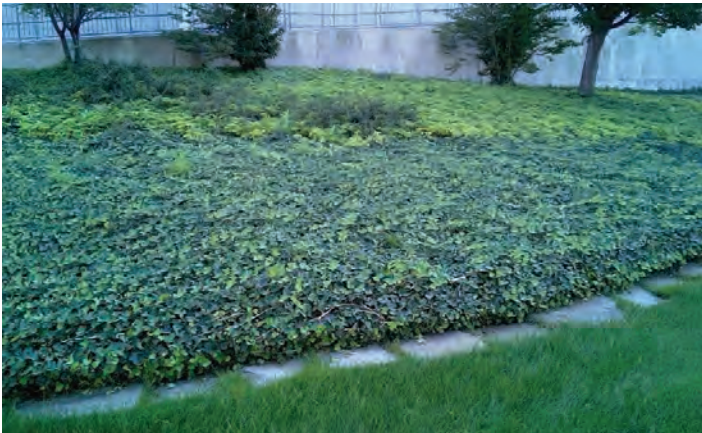
L3 - Ivy beds at the Northeast corner of the stadium

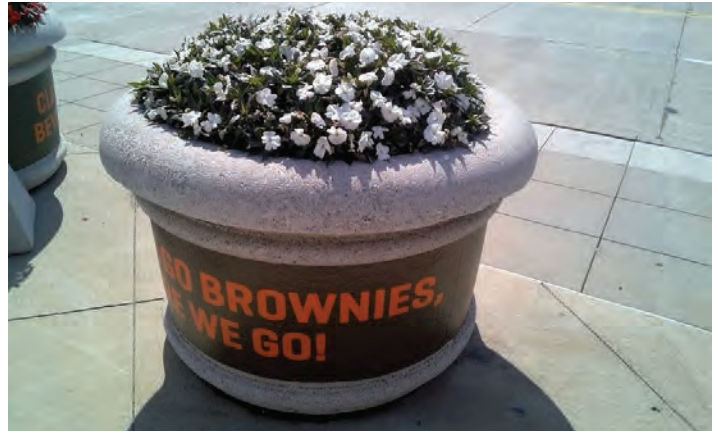
L5 - Precast concrete planter bed

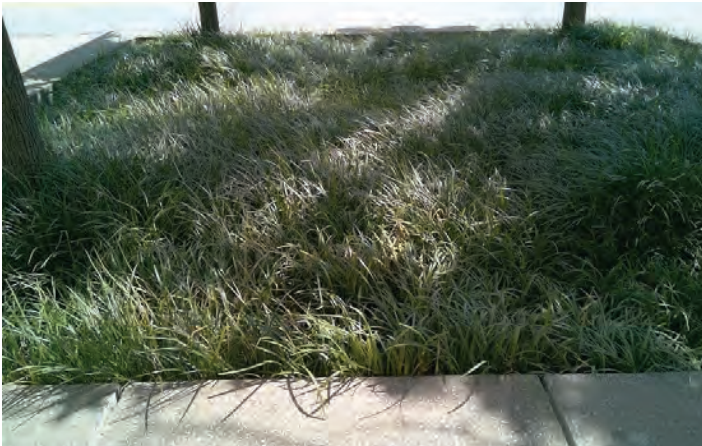
L4 - Liriope in planter bed

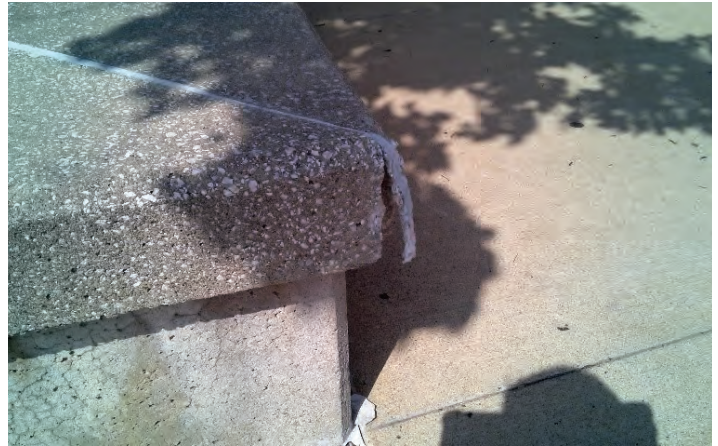
The four, square planters and the planter curb around the Ginkgo trees on the south side of the stadium were previously flagged in the URS 2014 Audit for repair within five years. See Photo L6. These repairs have still not occurred.

L6 - Planter bed precast concrete coping - poor condition

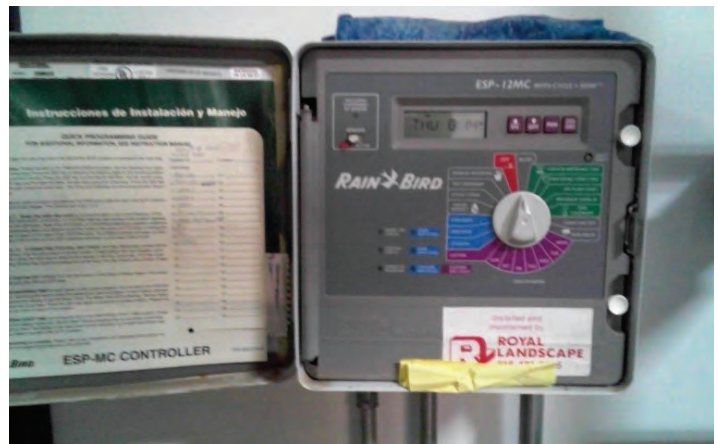
Larger concerns about the irrigation system center around aging components such as valves, sprinklers, and controllers. For example, the bronze GB solenoid valves originally specified for the project are no longer available, making parts replacement difficult. Similarly, the sprinkler models have changed. One of the rotor sprinklers originally specified for the project (T-6) is no longer manufactured. Two out of three of the controllers are not operating correctly and they are now considered old technology for large irrigation systems. See Photo L7. Today, two-wire control systems are much preferred that have ET capabilities.

L7 - Existing irrigation controller

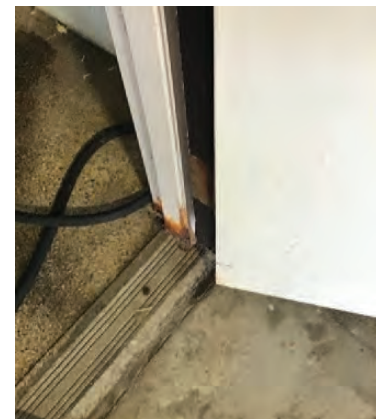
A4 - Typical hollow metal door rusting at base

At the Main, Club, and Upper Concourse levels, replace all hollow metal door assemblies with hardware over 6-10 year time period. Overhead coiling door assemblies at concession areas on Main, Club, and Upper Concourse levels should be replaced over 6-10 year time period. Repaint the perimeter security entrance gates at the main concourse level within the next year. Replace all gate hardware.

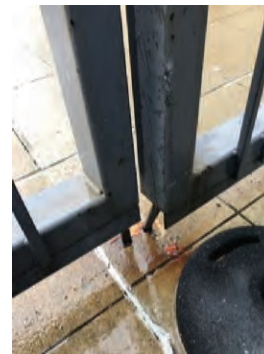
A5 - Typical security gate hardware (damaged cane bolt)

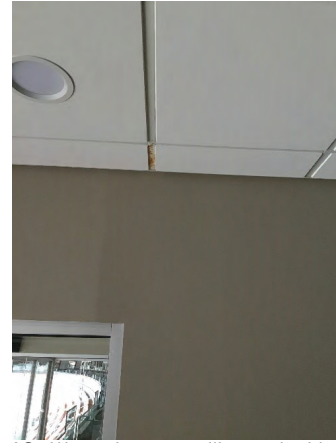
A8 - Water damage ceiling and grid

Within the next year, investigate issue causing condensate buildup and repair per mechanical suggestions. Address open sealant joints and cracks in the upper concourse deck per structural recommendations. Replace damaged finish ceilings and grid in the disturbed areas. Over 6 - 10 year time period, replace seating in the exterior balconies.

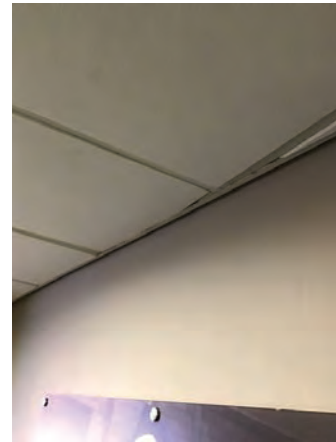
A9 - Water damage ceiling and grid

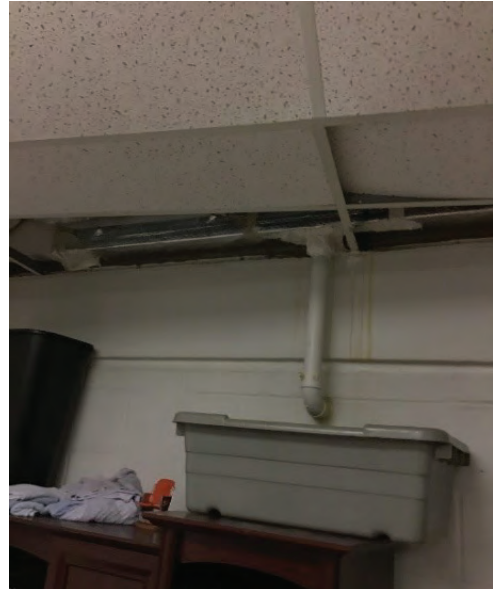
A13 - Water damage at finish ceiling

Maintain sealed concrete and epoxy floor finishes with routine/normal maintenance. Within the next year, wall finish should be repaired, and finish ceilings should be replaced. Replace hollow metal doors with associated hardware throughout the service level, quads A, C, and D over 6 – 10 year time frame.

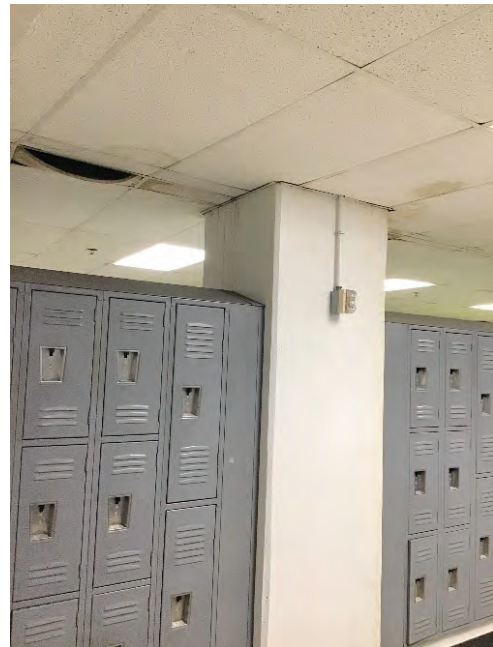
A14 - Water damage at finish ceiling

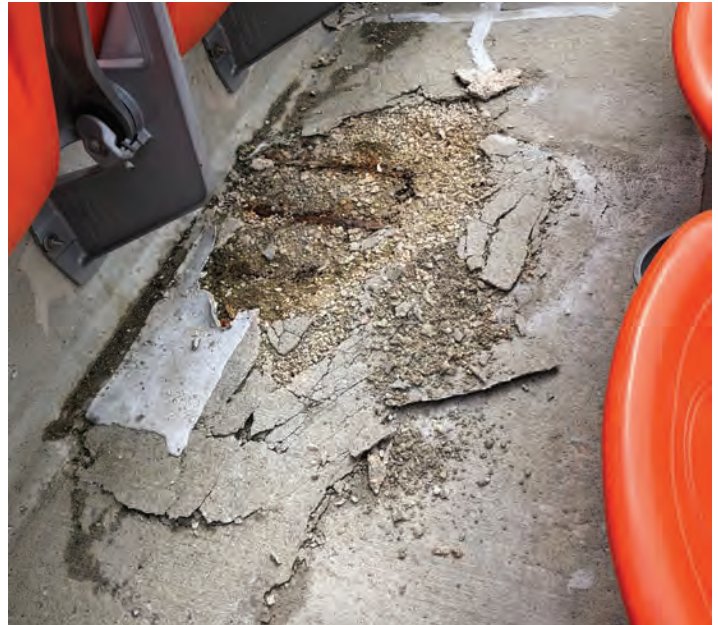
S1 - Typical Spalled Concrete

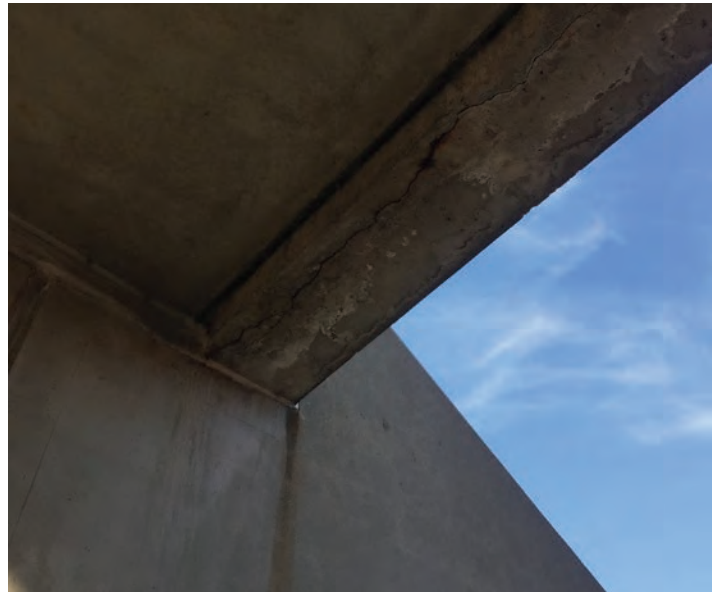
S2 - Typical Cracked Concrete

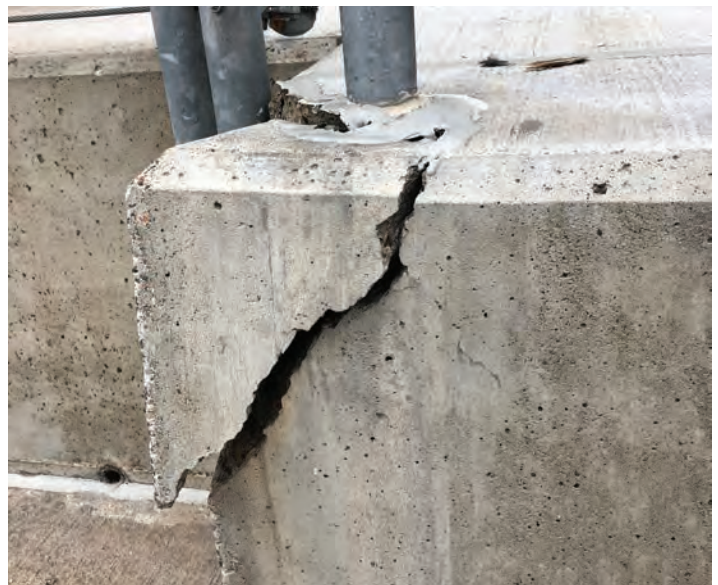
Guard rail posts: We observed deterioration of the concrete at several guard rail posts at both vomitory walls as well as in the seat deck aisles. Considering the number of guard rail posts in the stadium the number of observed failures is considered very low. See Photo S3.

S3 - Typical Concrete Damage at Guard Rail Post

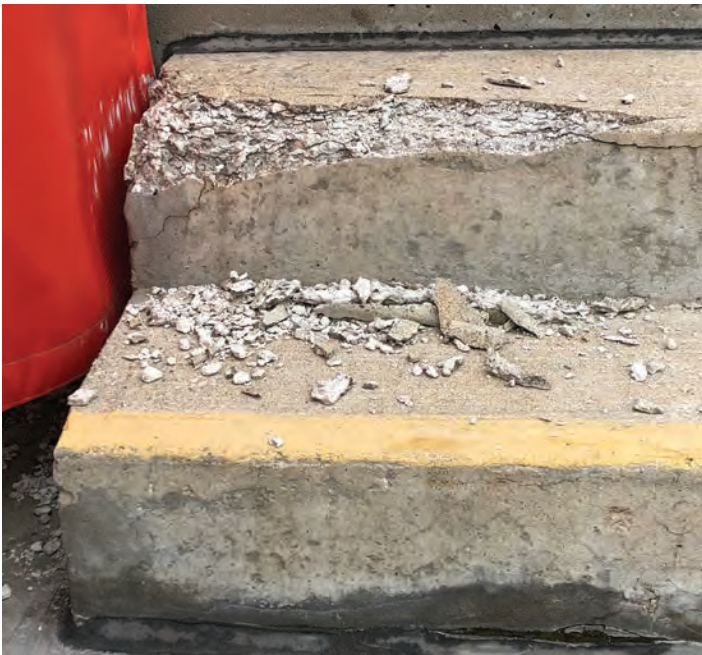
S4 - Typical Deteriorated Aisle Step

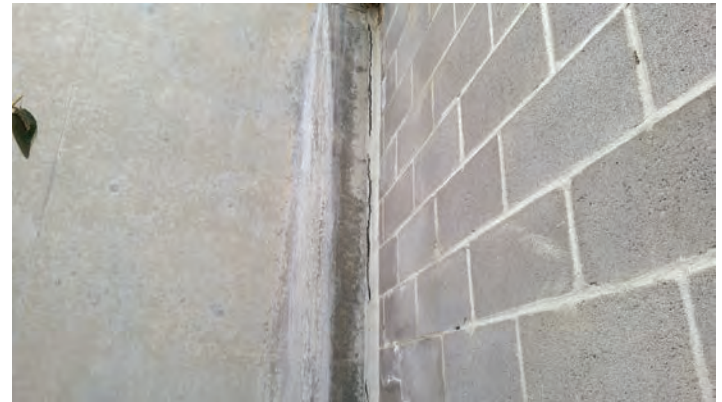
S6 - Typical Failed Backer Rod and Sealant Joint

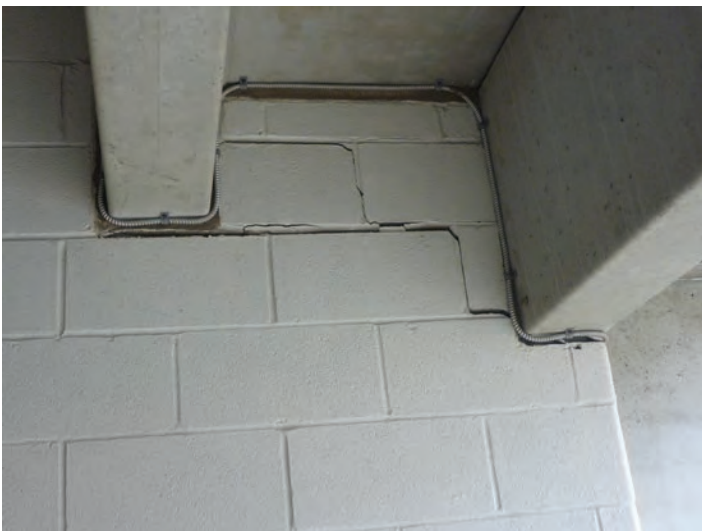
S5 - Typical Masonry Cracking at Vomitory Wall

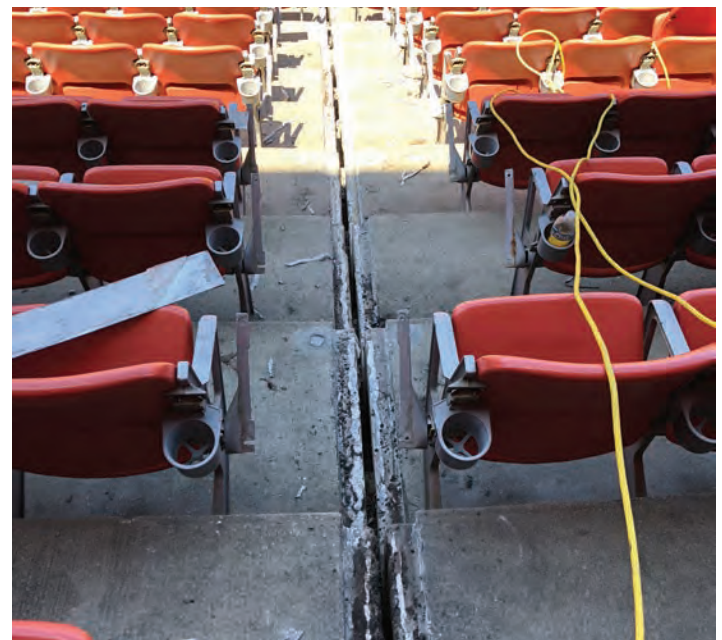
Precast joints: Each unit typically includes up to (3) three rows of seat deck. The precast units when originally installed necessitate filling the open joint between adjacent joints on both ends. The joints were filled with a pre-formed sealant material that is epoxied into position. As with other types of joints, the joint material begins to fail due to exposure to environmental conditions and UV rays. Many of the original joints have already been replaced over the past 10 years but there remains areas of seat deck where the joint material was installed during the original stadium construction. See Photo S7.

S7 - Typical Precast Joint

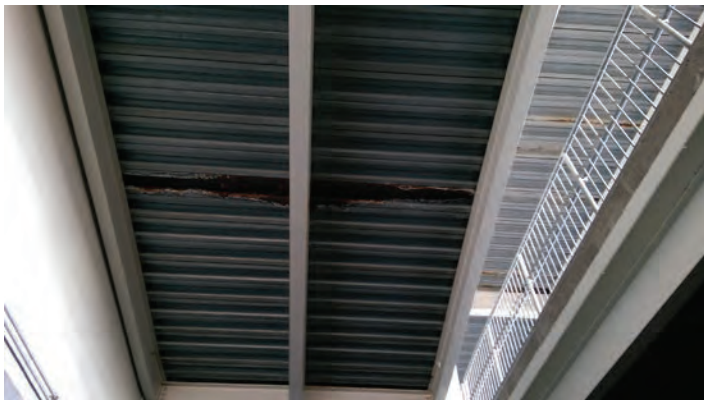
It must be noted that the City and Browns began implementing a replacement project for the ramps, bridges and ramp landings several years ago. As of this writing, all of the bridge slabs and ramp landings have been replaced and require no additional work at this time. Several of the ramp slabs on the NW ramp system have been replaced including (2) two ramps replaced in 2018. With that said, there are many additional ramps to be replaced in the stadium's four ramp systems located in each corner of the building. See Photo S8.

S8 - Typical Corroded Metal Floor Deck at Ramps

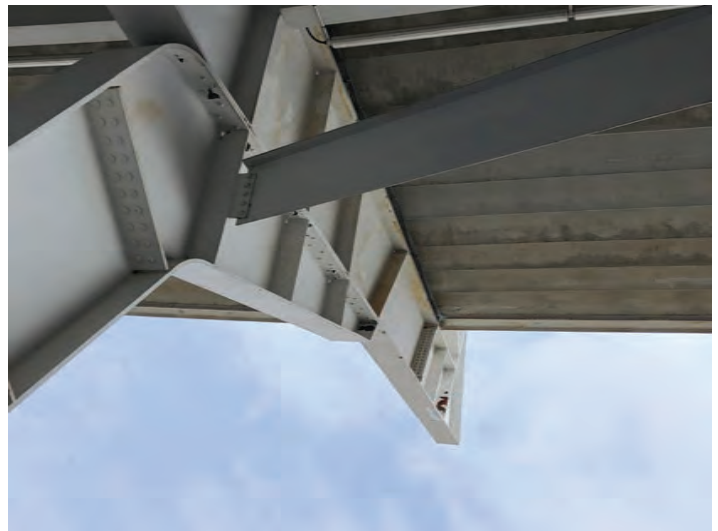
Touch-up painting: The quantity of exposed structural steel frame at FirstEnergy stadium is extensive with much of the building's steel columns and raker beams visible. Over time, the high performance paint coating begins to fail resulting in the development of surface corrosion. Due to the age of the coating it was expected that areas of failed paint can be found in localized areas throughout the stadium. See Photo S9.

S9 - Typical Surface Corrosion on Structural Framing Member

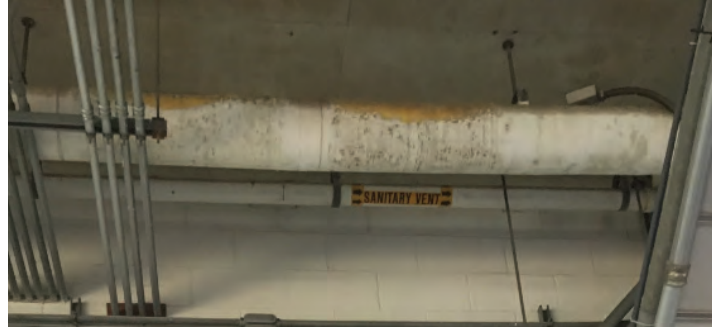
P1 - Domestic Water Insulation with worn off paper jacket

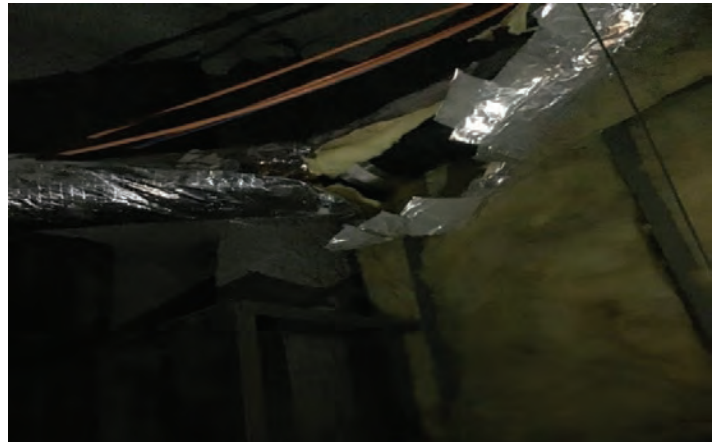
p2 - Unsecured Insulation in Suite Level Ceilings

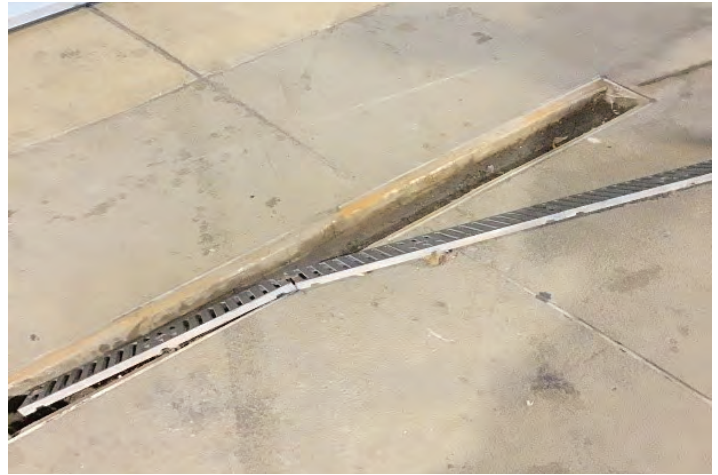
P3 - Unsecured trench drain gate

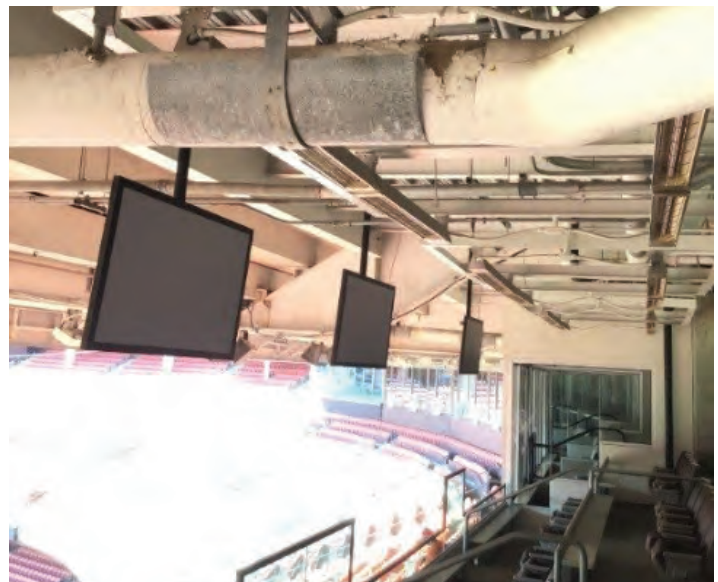
P4 - Disintegrating Storm Insulation

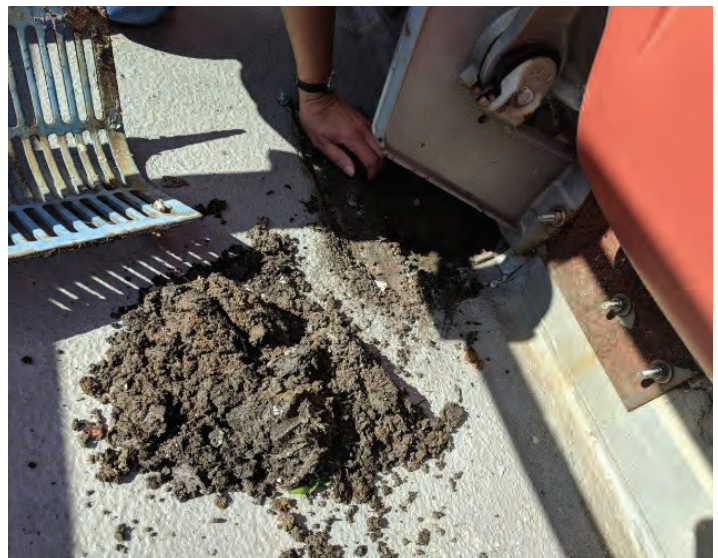
P5 - Bowl Drain Debris

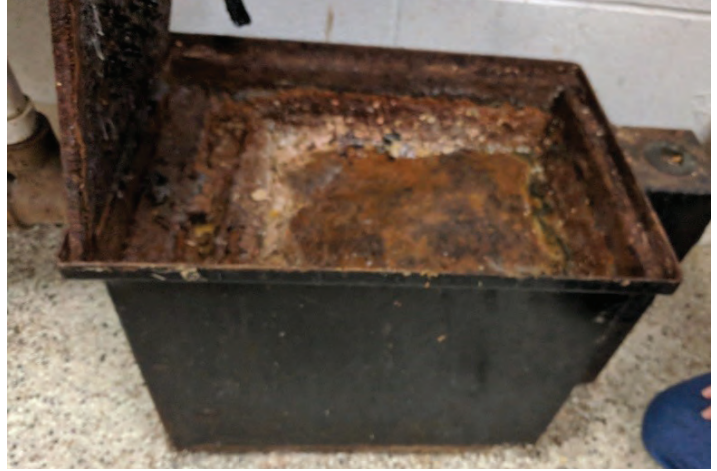
P6 - Rotted Grease Trap

To eliminate further clogging of the sanitary system, it is recommended that all grease traps in the facility be replaced with new equivalent units, as the current units that are rotting out are no longer effective.

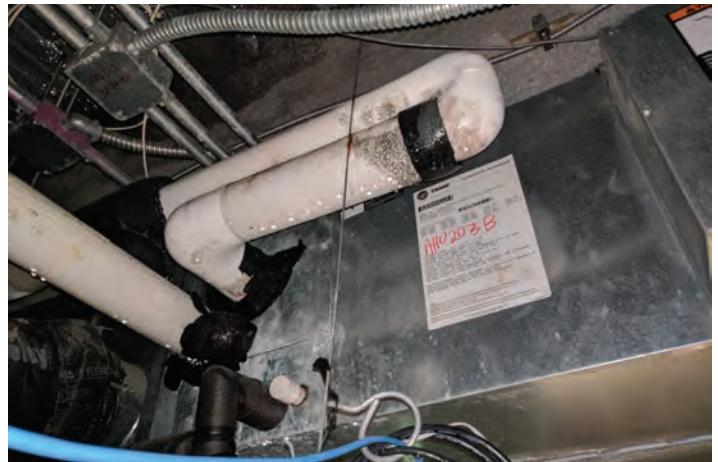
In the individual Suites at the fan coil unit, there is noticeable water saturation of the insulation and fibers possibly causing black mold. There appeared to be leaking drain valves or chilled water controls valves on the pipes. See Photo M1.

M1 - Water Saturated Insulation; FCU Chilled Water Piping

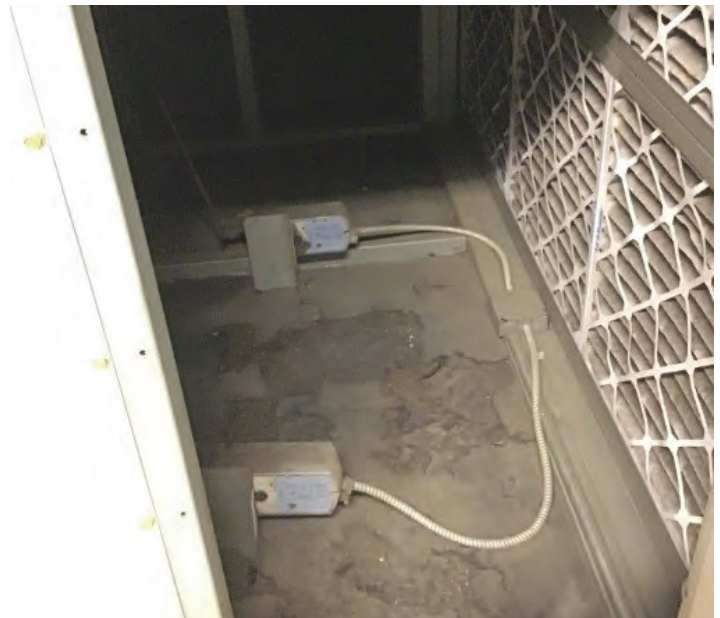
M2 - AHU Deteriorating Internal Lining

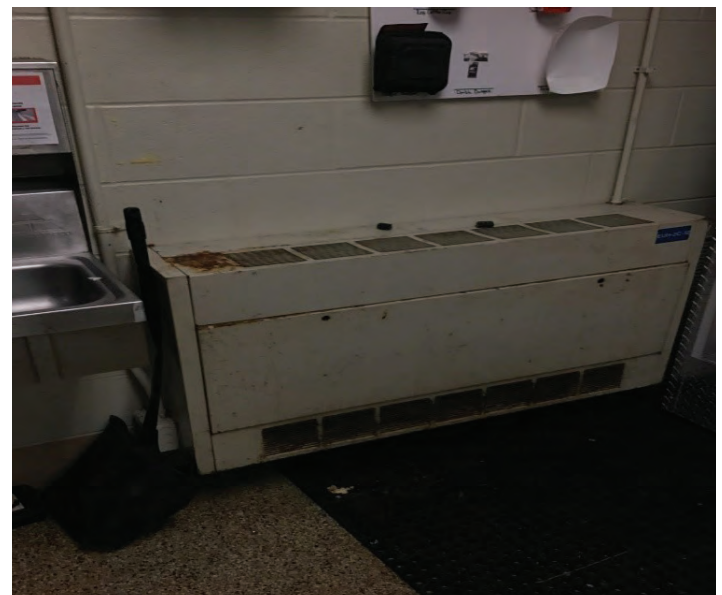
The cabinet heaters in the restrooms and concessions are visually in poor shape; with rust and heavy usage visibly apparent. Internal components on the heaters such as contactors have been in need of replacement with the parts becoming increasing difficult to obtain. See Photo M4.

M4 - Rusty Cabinet Unit Heaters

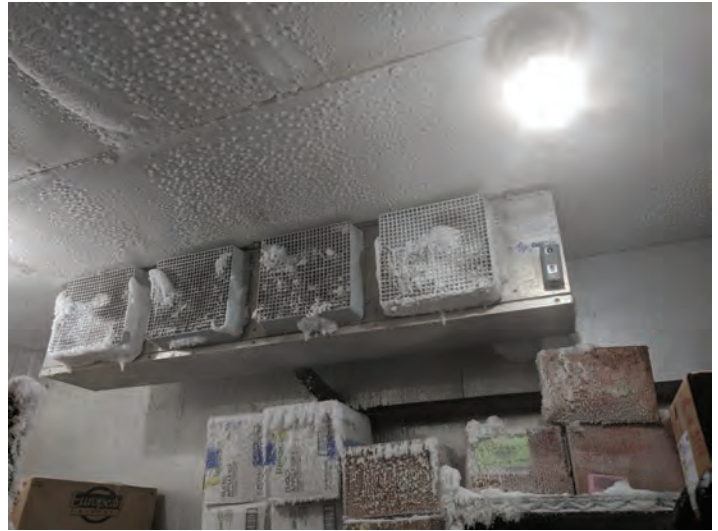
M6 - Ice Build-up on Evaporator and Freezer Contents

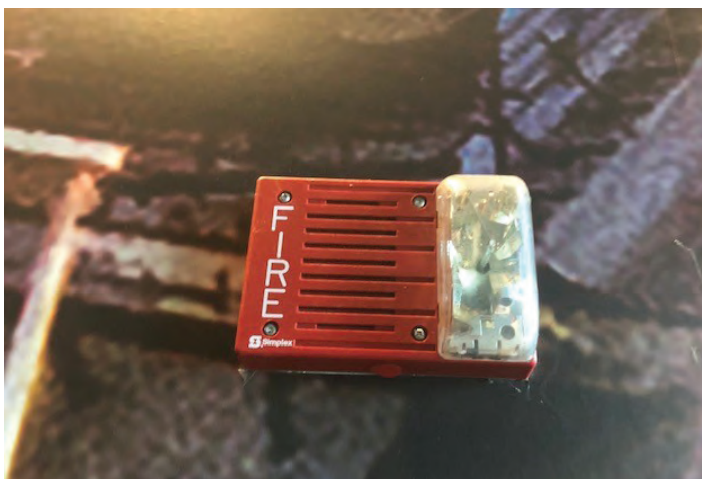
Many of the devices on the 100, 300, and 500 concourse levels show significant wear where exposed to weather. The strobe housing is clouded and dirty which limits the candela that is produced when the device operates. See Photo F1.

F1 - Cloudy Fire Alarm Device

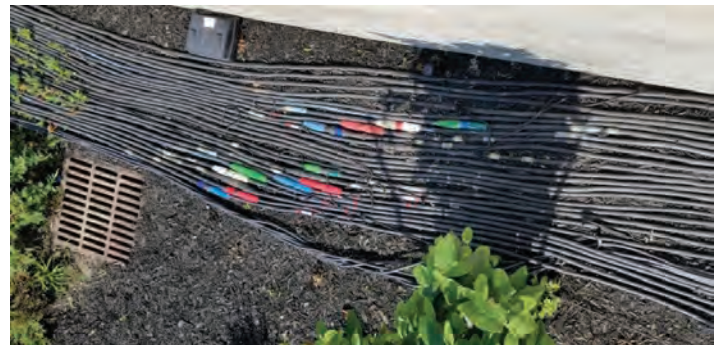
E15 - Temporary power cables laid on ground - north side

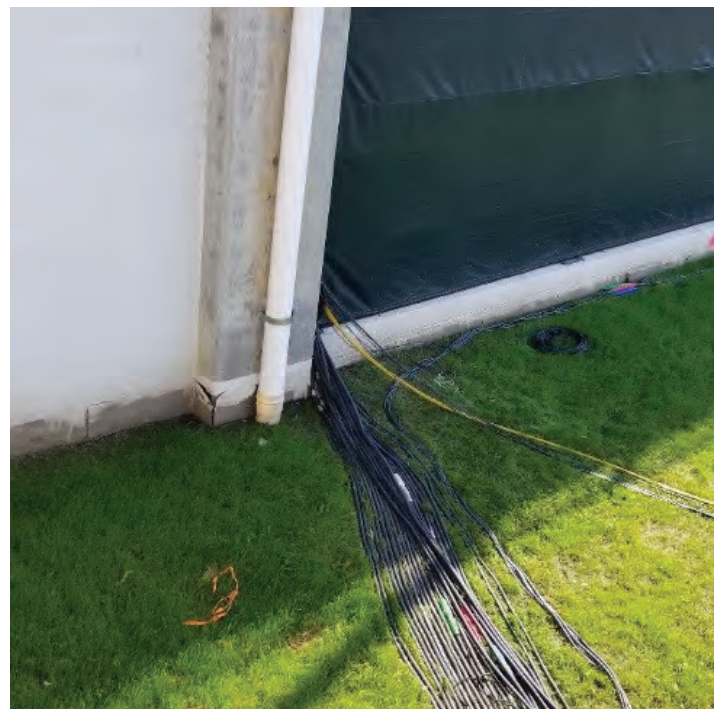
E16 - Temporary power cables entering service area

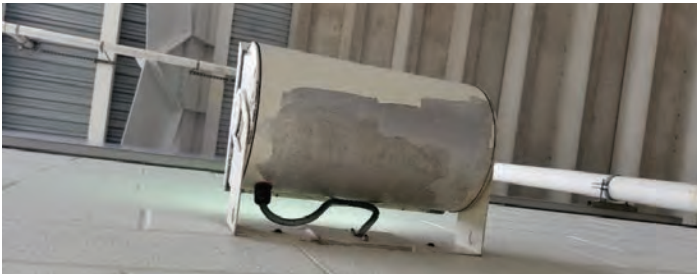
E8 - Typical wall mounted HID fixture showing corrosion
