LEU ROCKWELL ENTRY / SECURITY IMPROVEMENTS

Rockwell Avenue Existing Conditions

THE FEDERAL RESERVE BANK
 CLEVELAND
 1468 West Sixth Street
 Cleveland, Ohio 44101-1387

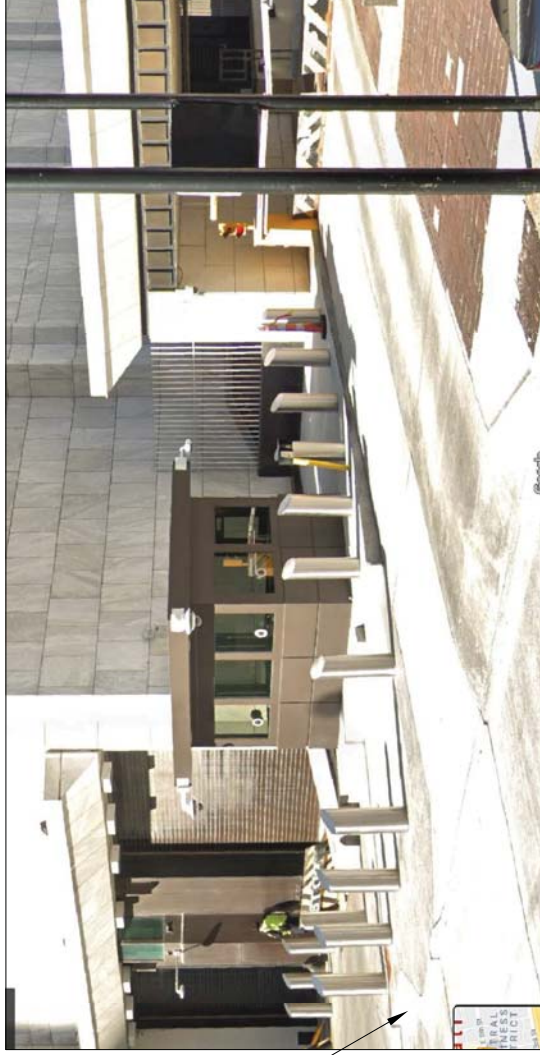
Widened walk and bollard area; new street pavement

Recently Installed 3-Officer Post at the Cincinnati Branch

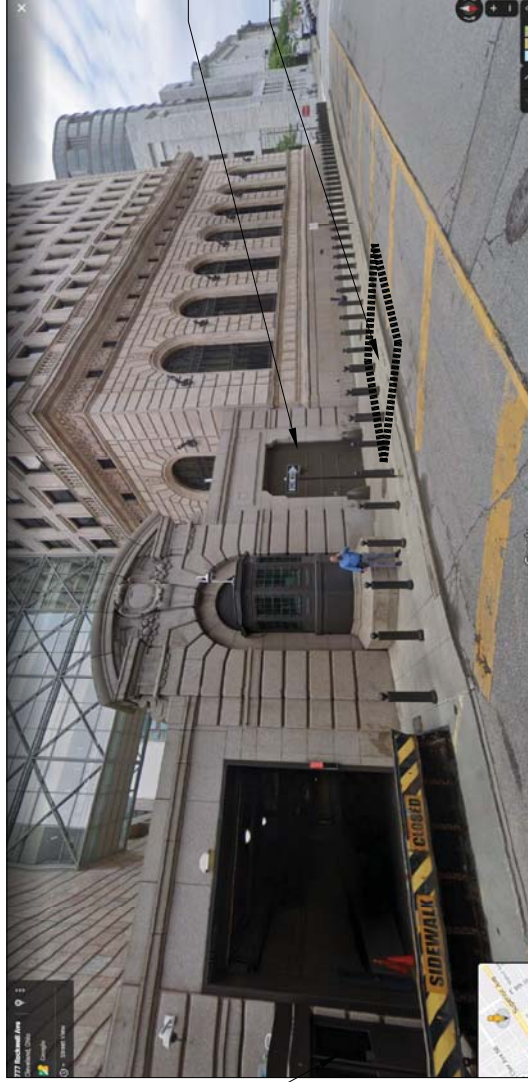
1 Existing Site Photos

Existing Single Officer Post to be replaced

Proposed location for refurbished entry for vendors and staff.

Proposed location for new 3-Officer Post. See site plan for accurate location.

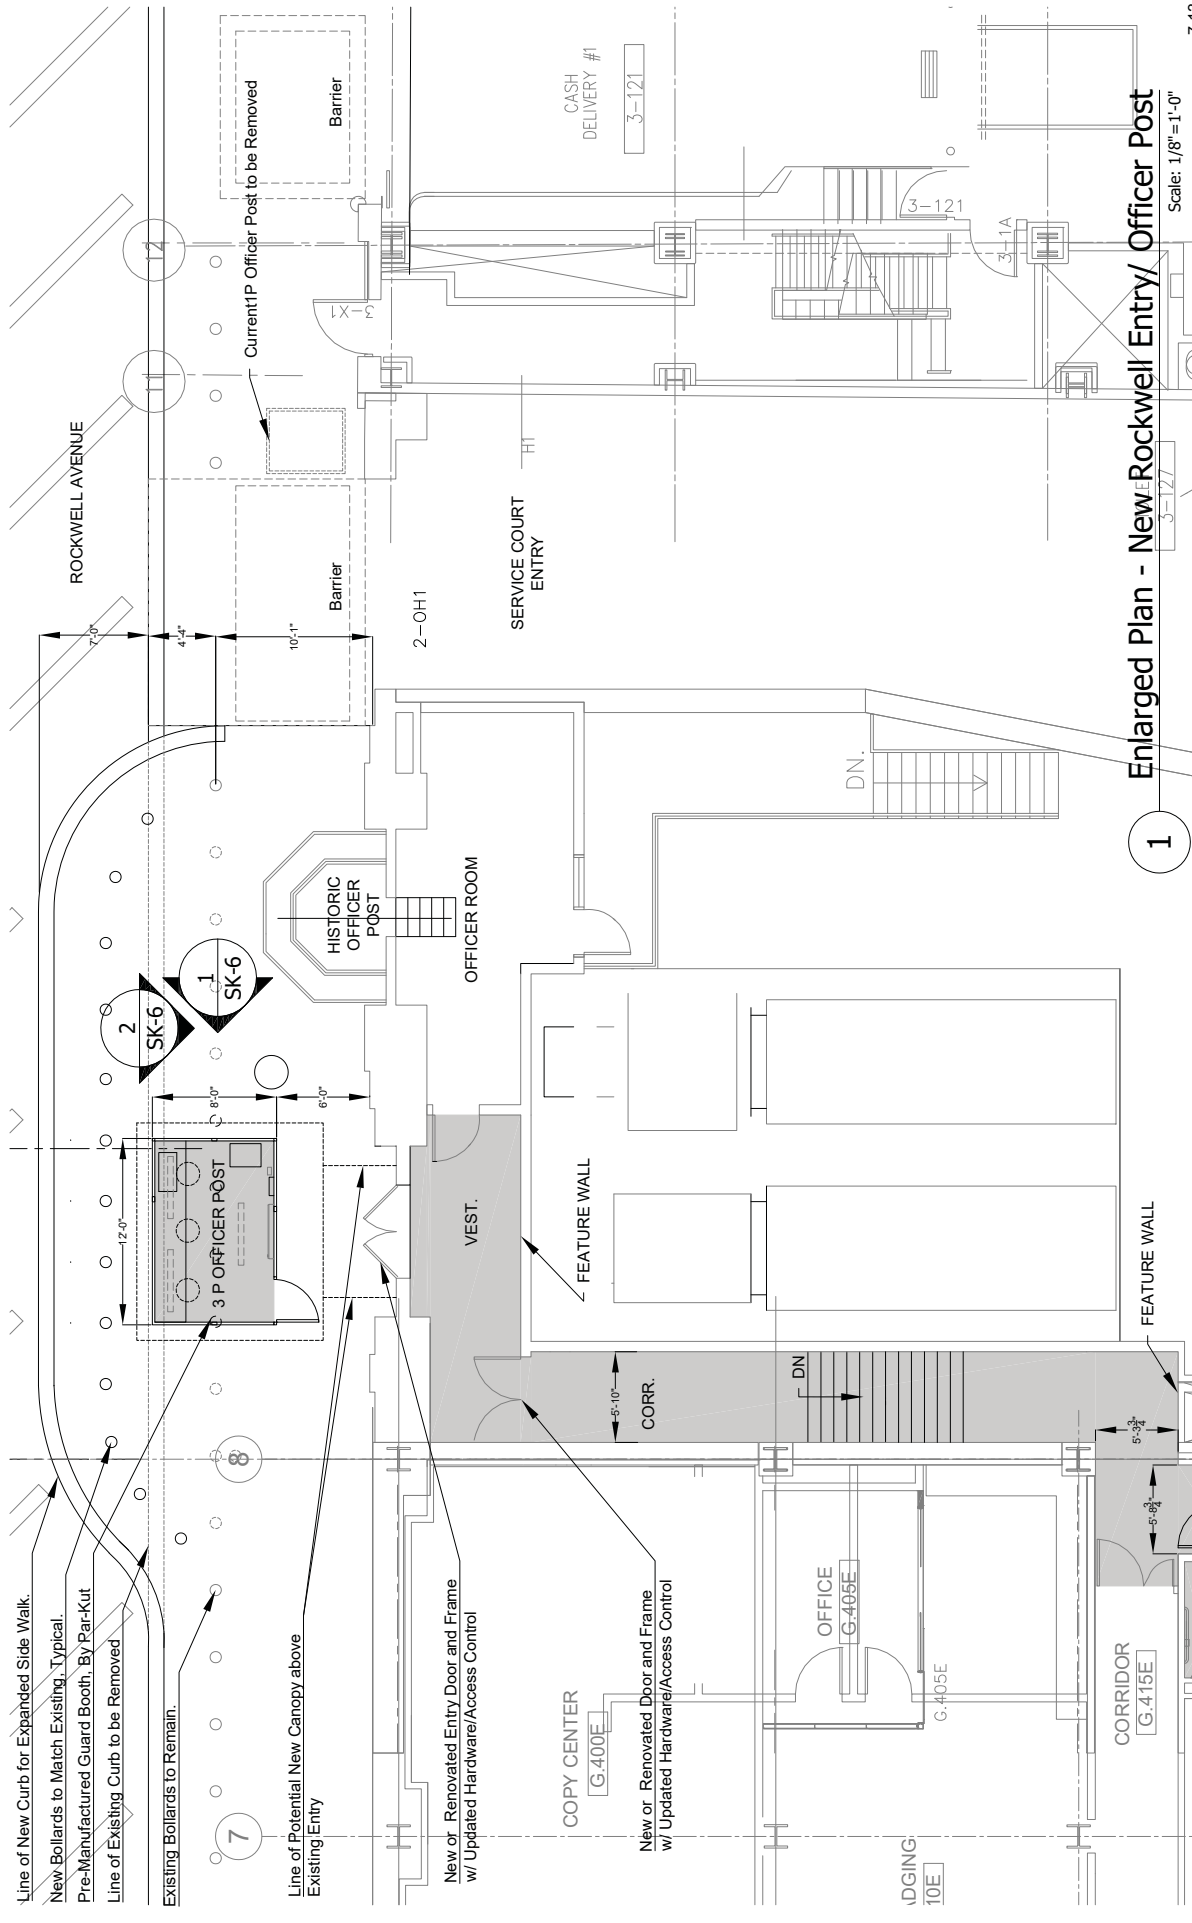
SK-2

Line of New Curb for Expanded Side Walk.
 New Bollards to Match Existing, Typical.
 Pre-Manufactured Guard Booth, By Par-Kut
 Line of Existing Curb to be Removed
 Existing Bollards to Remain.

Line of Potential New Canopy above Existing Entry

New or Renovated Entry Door and Frame w/ Updated Hardware/Access Control

New or Renovated Door and Frame w/ Updated Hardware/Access Control

Enlarged Plan - New Rockwell Entry / Officer Post
 Scale: 1/8" = 1'-0"
