Subject: *2018 Capital Repair Audit of First Energy Stadium*

2018 CAPITAL REPAIR AUDIT FOR FIRSTENERGY STADIUM FOR THE CITY OF CLEVELAND

OSBORN ENGINEERING
FEBRUARY 11, 2019

Re: 2018 Capital Repair Audit of FirstEnergy Stadium (Rev #1)

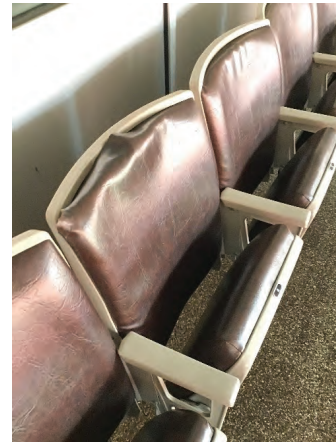
A10 - Seating at suite balconies

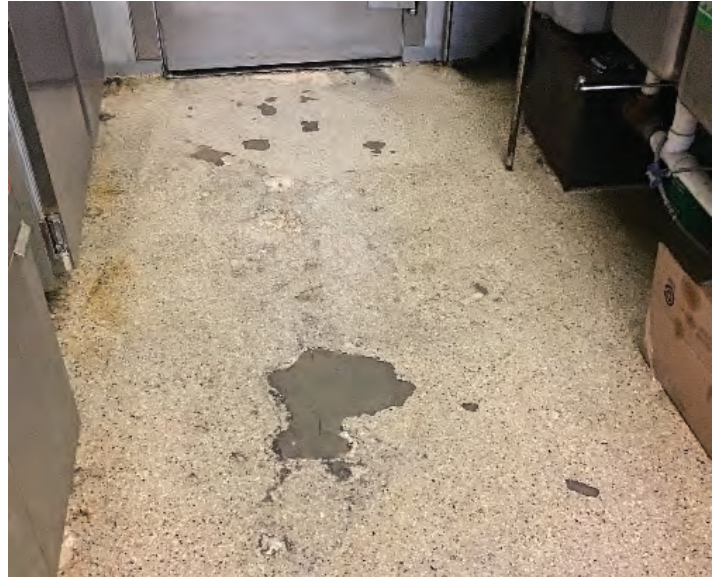
A11 - Epoxy floor in kitchen area

Maintain sealed concrete and tile floor finishes with routine/normal maintenance. Over 6 – 10 year time period, epoxy flooring and finish ceiling should be replaced.

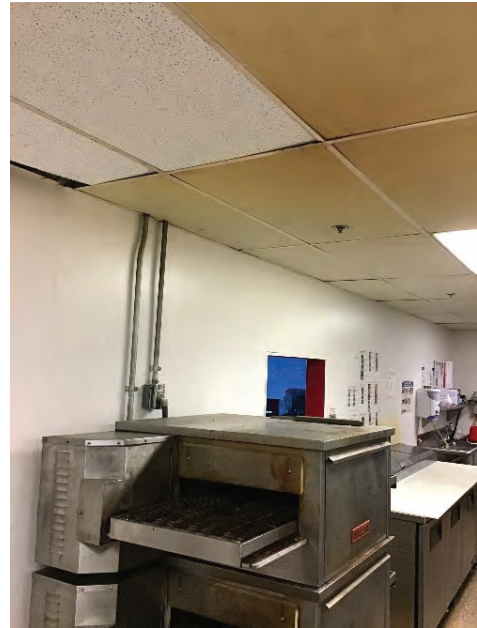
A12 - Finish ceiling in kitchen area

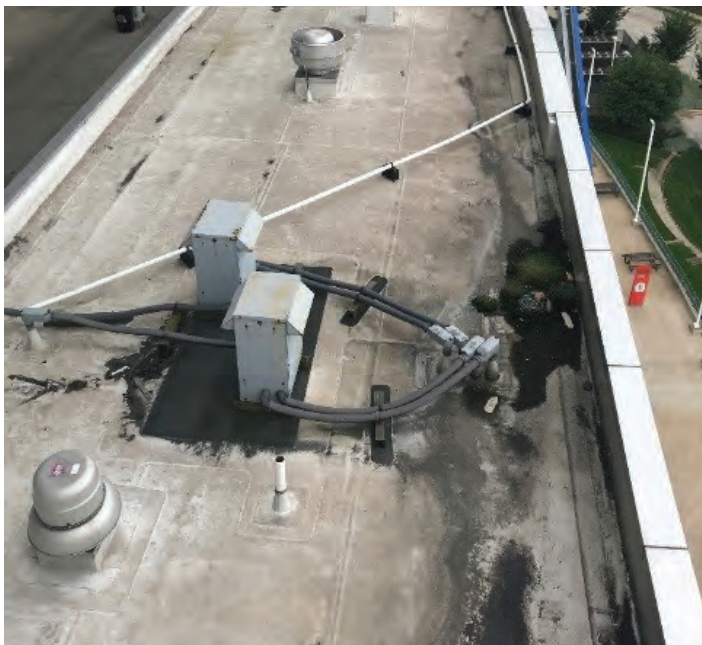
E3 - Upper concourse roof top transformers over concessions

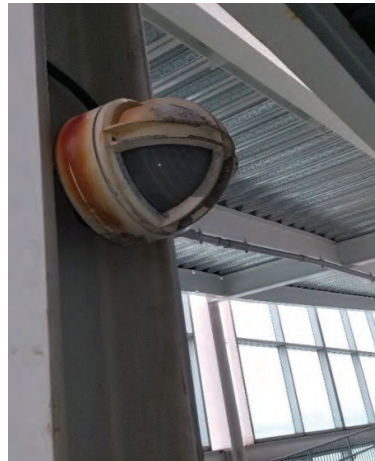
E4 - Typical interior ramp fixture

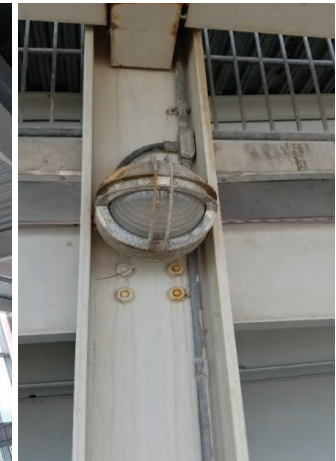
E5 - Typical interior ramp fixture

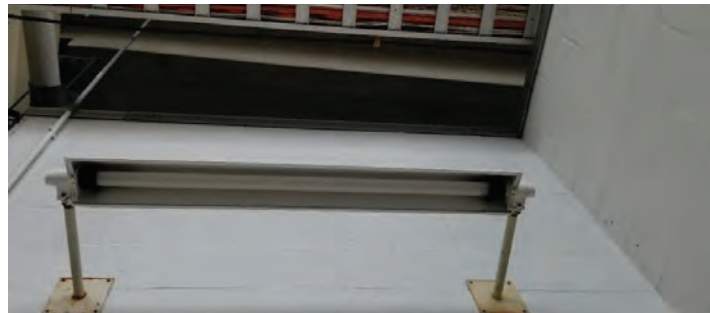
E9 - Linear fluorescent fixture in concourse

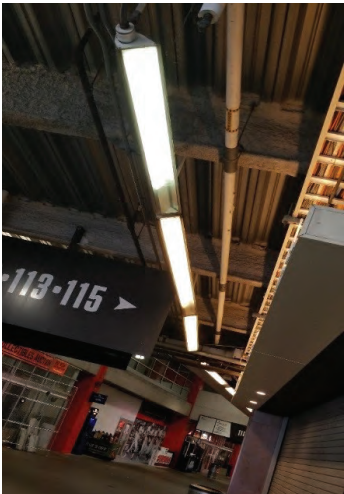
The overhead lighting in the main concourse has been updated to LED. However the ancillary linear fixtures which provide accent lighting are fluorescent in 4 and 8 foot lengths. These date from original construction and are in fair condition. They run along the side of the concourse and are mounted over the niches at toilet rooms. See Photo E6.

E6 - Main Concourse linear fixture

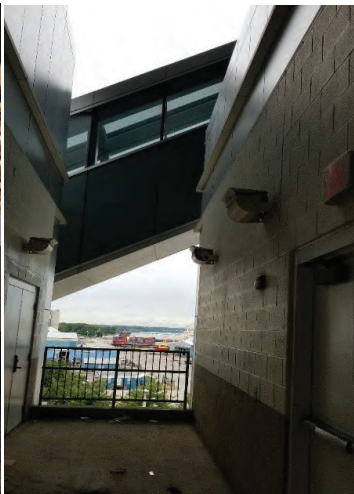
E7 - Typical wall mounted HID Fixture

There are other miscellaneous HID wall bracket fixtures throughout, most in fair to poor condition. See Photos E7 & E8.

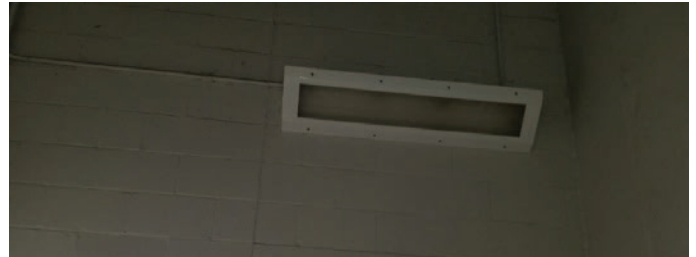
E11 - Typical toilet room corner mounted fluorescent fixture

3. Toilet rooms: Concourses, back of house. Typically lighting is fluorescent, 4' linear in concourse rooms, troffer type in back of house See Photo E11. Although fixtures are generally in good condition, they are dated and energy inefficient.

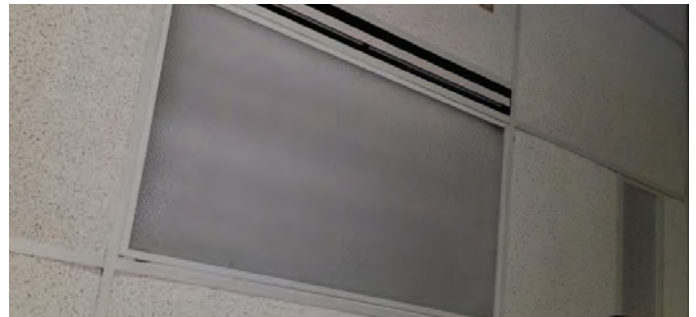
E13 - Typical troffer type fluorescent in "back-of-house" location

5. Suites: - The suite lighting has been upgraded to LED throughout and requires no action at this time.
6. Offices, Press areas, Broadcast Booths: These areas typically use fluorescent troffers, downlights also in booths, many incandescent. See Photo E13. Fixtures generally fair to good, but dated and energy inefficient.

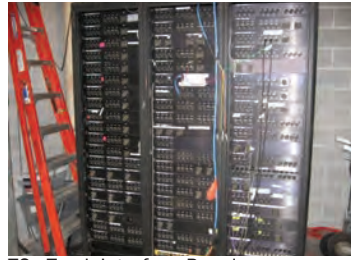
T2 - Truck Interface Panels

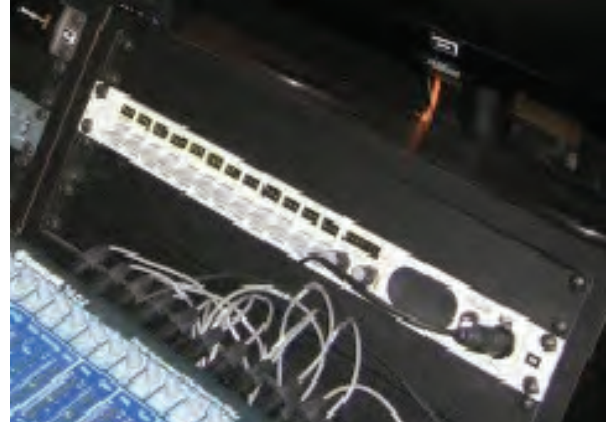
T3 - Intercom Panels

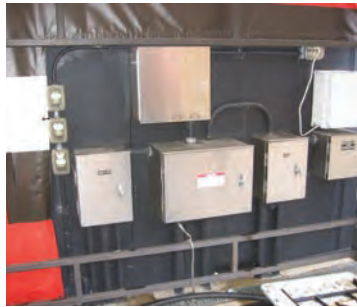
T1 - Stadium Interface panels

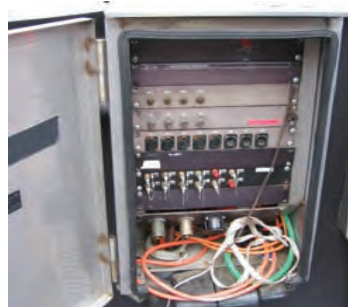
T1B - Internal View
