Bedrock Community Benefits Agreement Term Sheet

BEDROCK | CUYAHOGA RIVERFRONT MASTER PLAN

FINDINGS AND CONTRIBUTING FACTORS

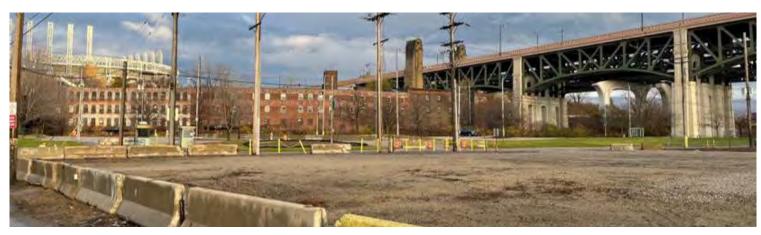
On this site, seven parcels in the Tower City Center are abandoned structures and five outdoor parcels are vacant.

Examples of the vacant outdoor parcels at Fundamental Parking parcels.

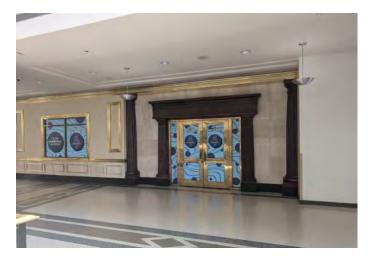
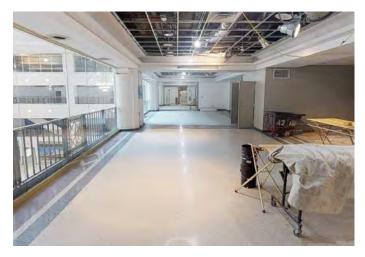
Examples of the numerous indoor vacancies in Tower City.

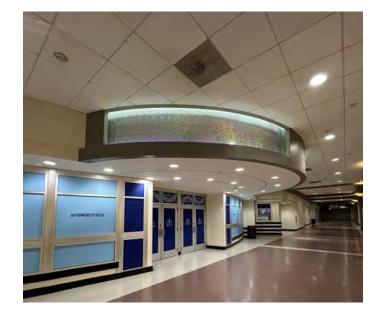
Examples of additional indoor vacancies in Tower City.
