Subject: *2018 Capital Repair Audit of First Energy Stadium*

2018 CAPITAL REPAIR AUDIT FOR FIRSTENERGY STADIUM FOR THE CITY OF CLEVELAND

OSBORN ENGINEERING
FEBRUARY 11, 2019

Re: 2018 Capital Repair Audit of FirstEnergy Stadium (Rev #1)

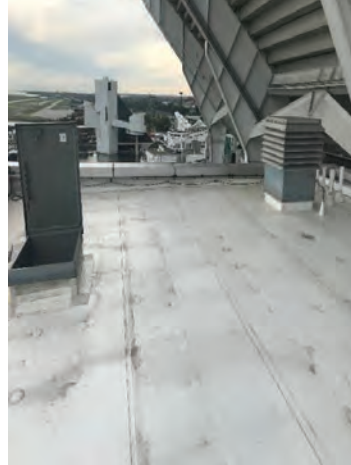
Roofing consists of single-ply membranes and metal standing seam deck. The membrane roofs are located at the Club and Upper Concourse Areas. The metal roofing is located on the canopies above the Upper Deck Seating Areas and consists of galvanized metal decking. Observed conditions of the membrane roofing showed no signs of leaking. See Photo A1. Parapet caps and sealant appear weathertight. Flashing and seams appear undamaged. No major water ponding was seen. Some roof areas had collected debris at the perimeter of roof drains. Surface rust was observed on roughly 30 to 40% of the metal roofing above the north Upper Deck Seating Area. Material loss of the decking was not seen. See Photo A2.

A1 - Typical single-ply membrane roof

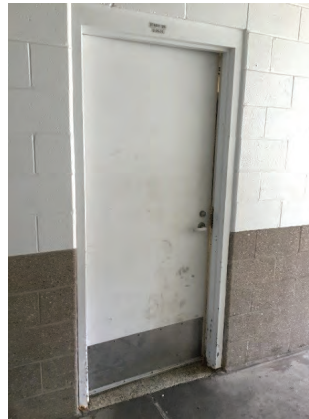
A3 - Typical hollow metal door assembly

At the Main, Club, and Upper Concourse levels, replace all hollow metal door assemblies with hardware over 6-10 year time period. Overhead coiling door assemblies at concession areas on Main, Club, and Upper Concourse levels should be replaced over 6-10 year time period. Repaint the perimeter security entrance gates at the main concourse level within the next year. Replace all gate hardware.

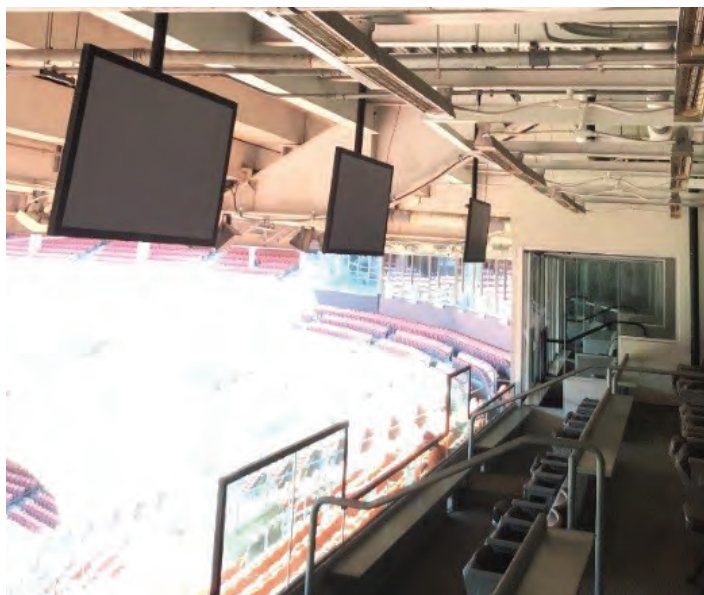
It was noted during discussions with Browns maintenance staff that the Upper and Lower suite level outdoor radiant heaters are a complaint among suite owners. Original radiant heaters located on the outdoor suite seating areas take a noticeably long time to heat up, and in some cases they give out a diminished level of heat output. Heat output varies among suites, with some providing more heat than others. A uniform level of outdoor heating is not experienced by suite owners.

M3 - Typical Radiant Heater Layout

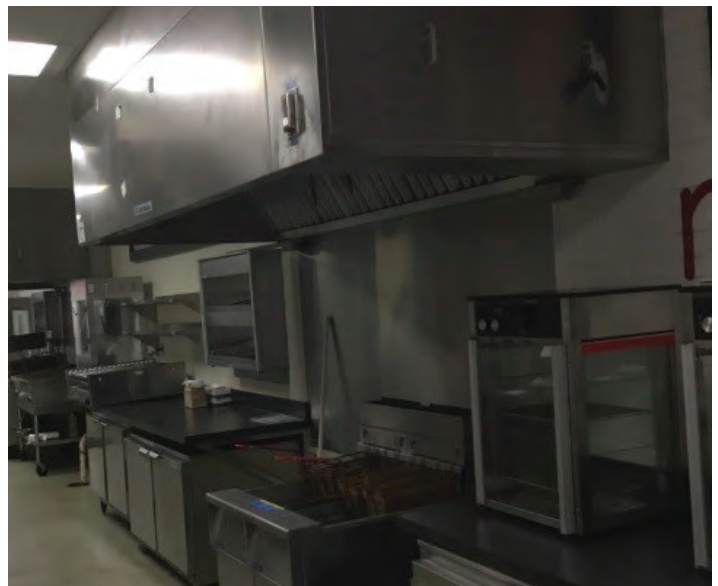
Equipment effluent that cannot be contained properly shall be moved to a different location with the proper size exhaust hood. A new exhaust hoods shall be provided over the steamer to remove moisture properly.

M5 - Typical Concession Exhaust Hood

We recommend replacement of all roof and in-line mounted exhaust fans in the near future except for the units that were added/replaced already in the 2014 renovation.

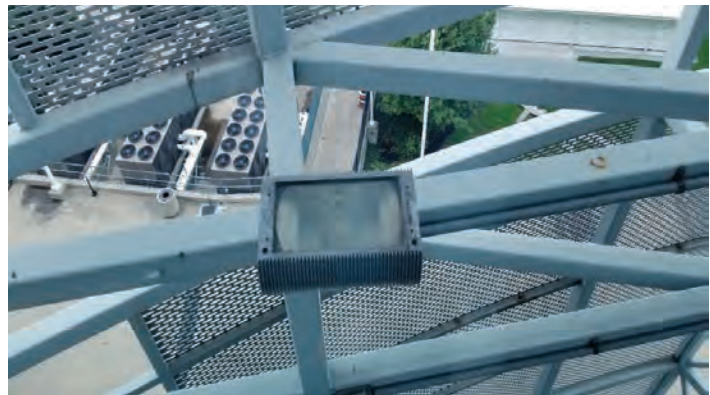
E10 - HID fixture mounted behind windscreen

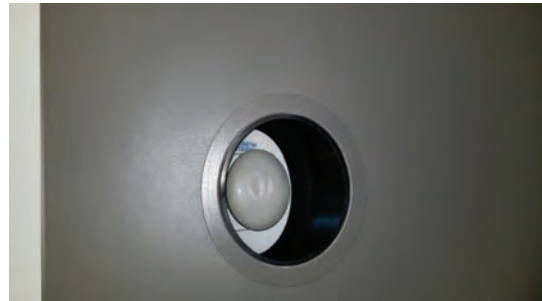
E14 - Typical fluorescent downlight over Suite entry doors

4. Corridors: The lower and upper suite levels use 2 x 2 fluorescent troffers, downlights with CFL's (spiral type fluorescent, See Photo E14) are over each suite door. Again the lighting is dated and energy inefficient, in particular the downlights need to be upgraded to LED as CFL's are rapidly leaving the market.

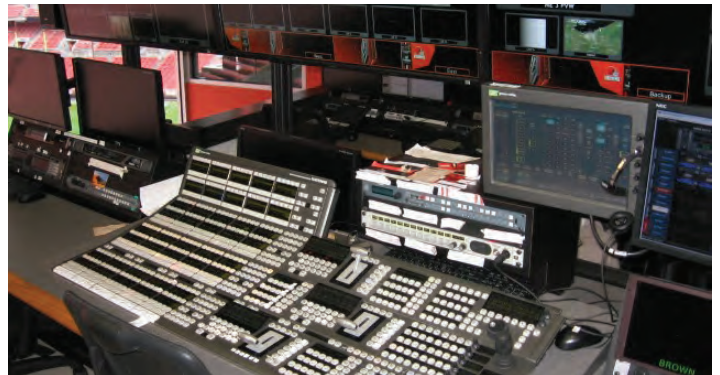
T6 - Grass Valley Video Switching

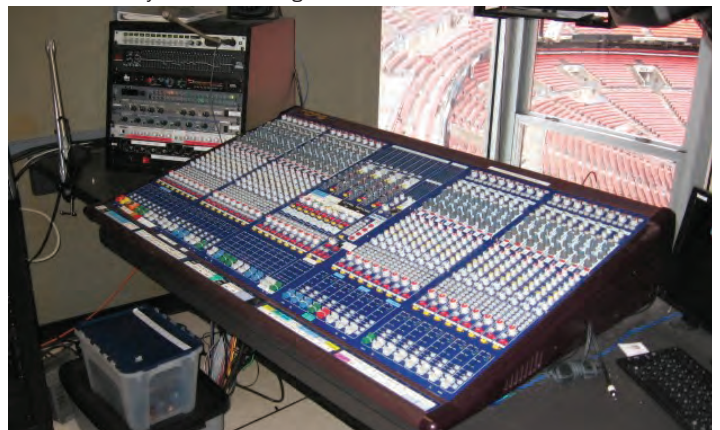
T7 - Midas Audio Mixer

- #7 Replace Main audio Midas mixer. Consider Digital models now available by 2023. See Photo T7.

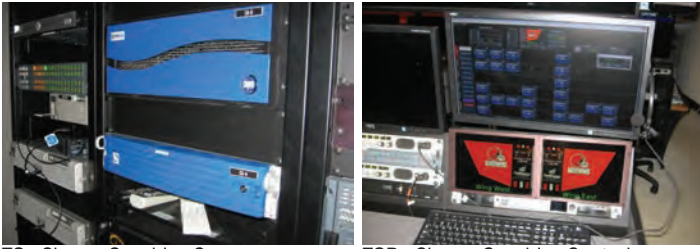
Graphics is supplied by an older Chyron Mosaic Hyper X Graphics system. See Photos T8 & T8B.

T8 - Chyron Graphics Core

T8B - Chyron Graphics Control

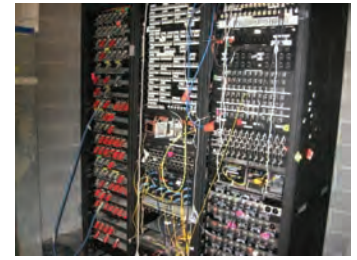
T2B - Truck Interface Panels

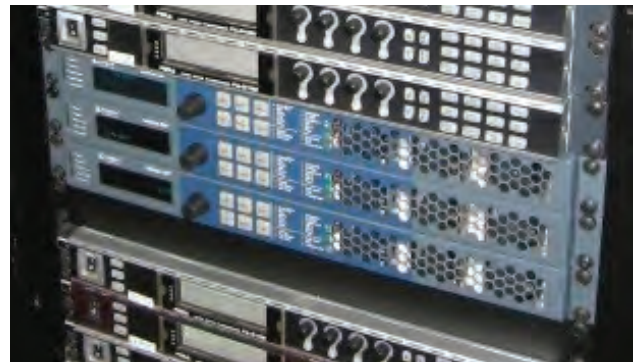
T4 - Frame Synchronizers
